Project No. 07516-42-02
February 9, 2022

Subject: ADDENDUM GEOTECHNICAL REPORT AND
RESPONSE TO CITY OF SAN DIEGO REVIEW COMMENTS
NAKANO
SAN DIEGO, CALIFORNIA

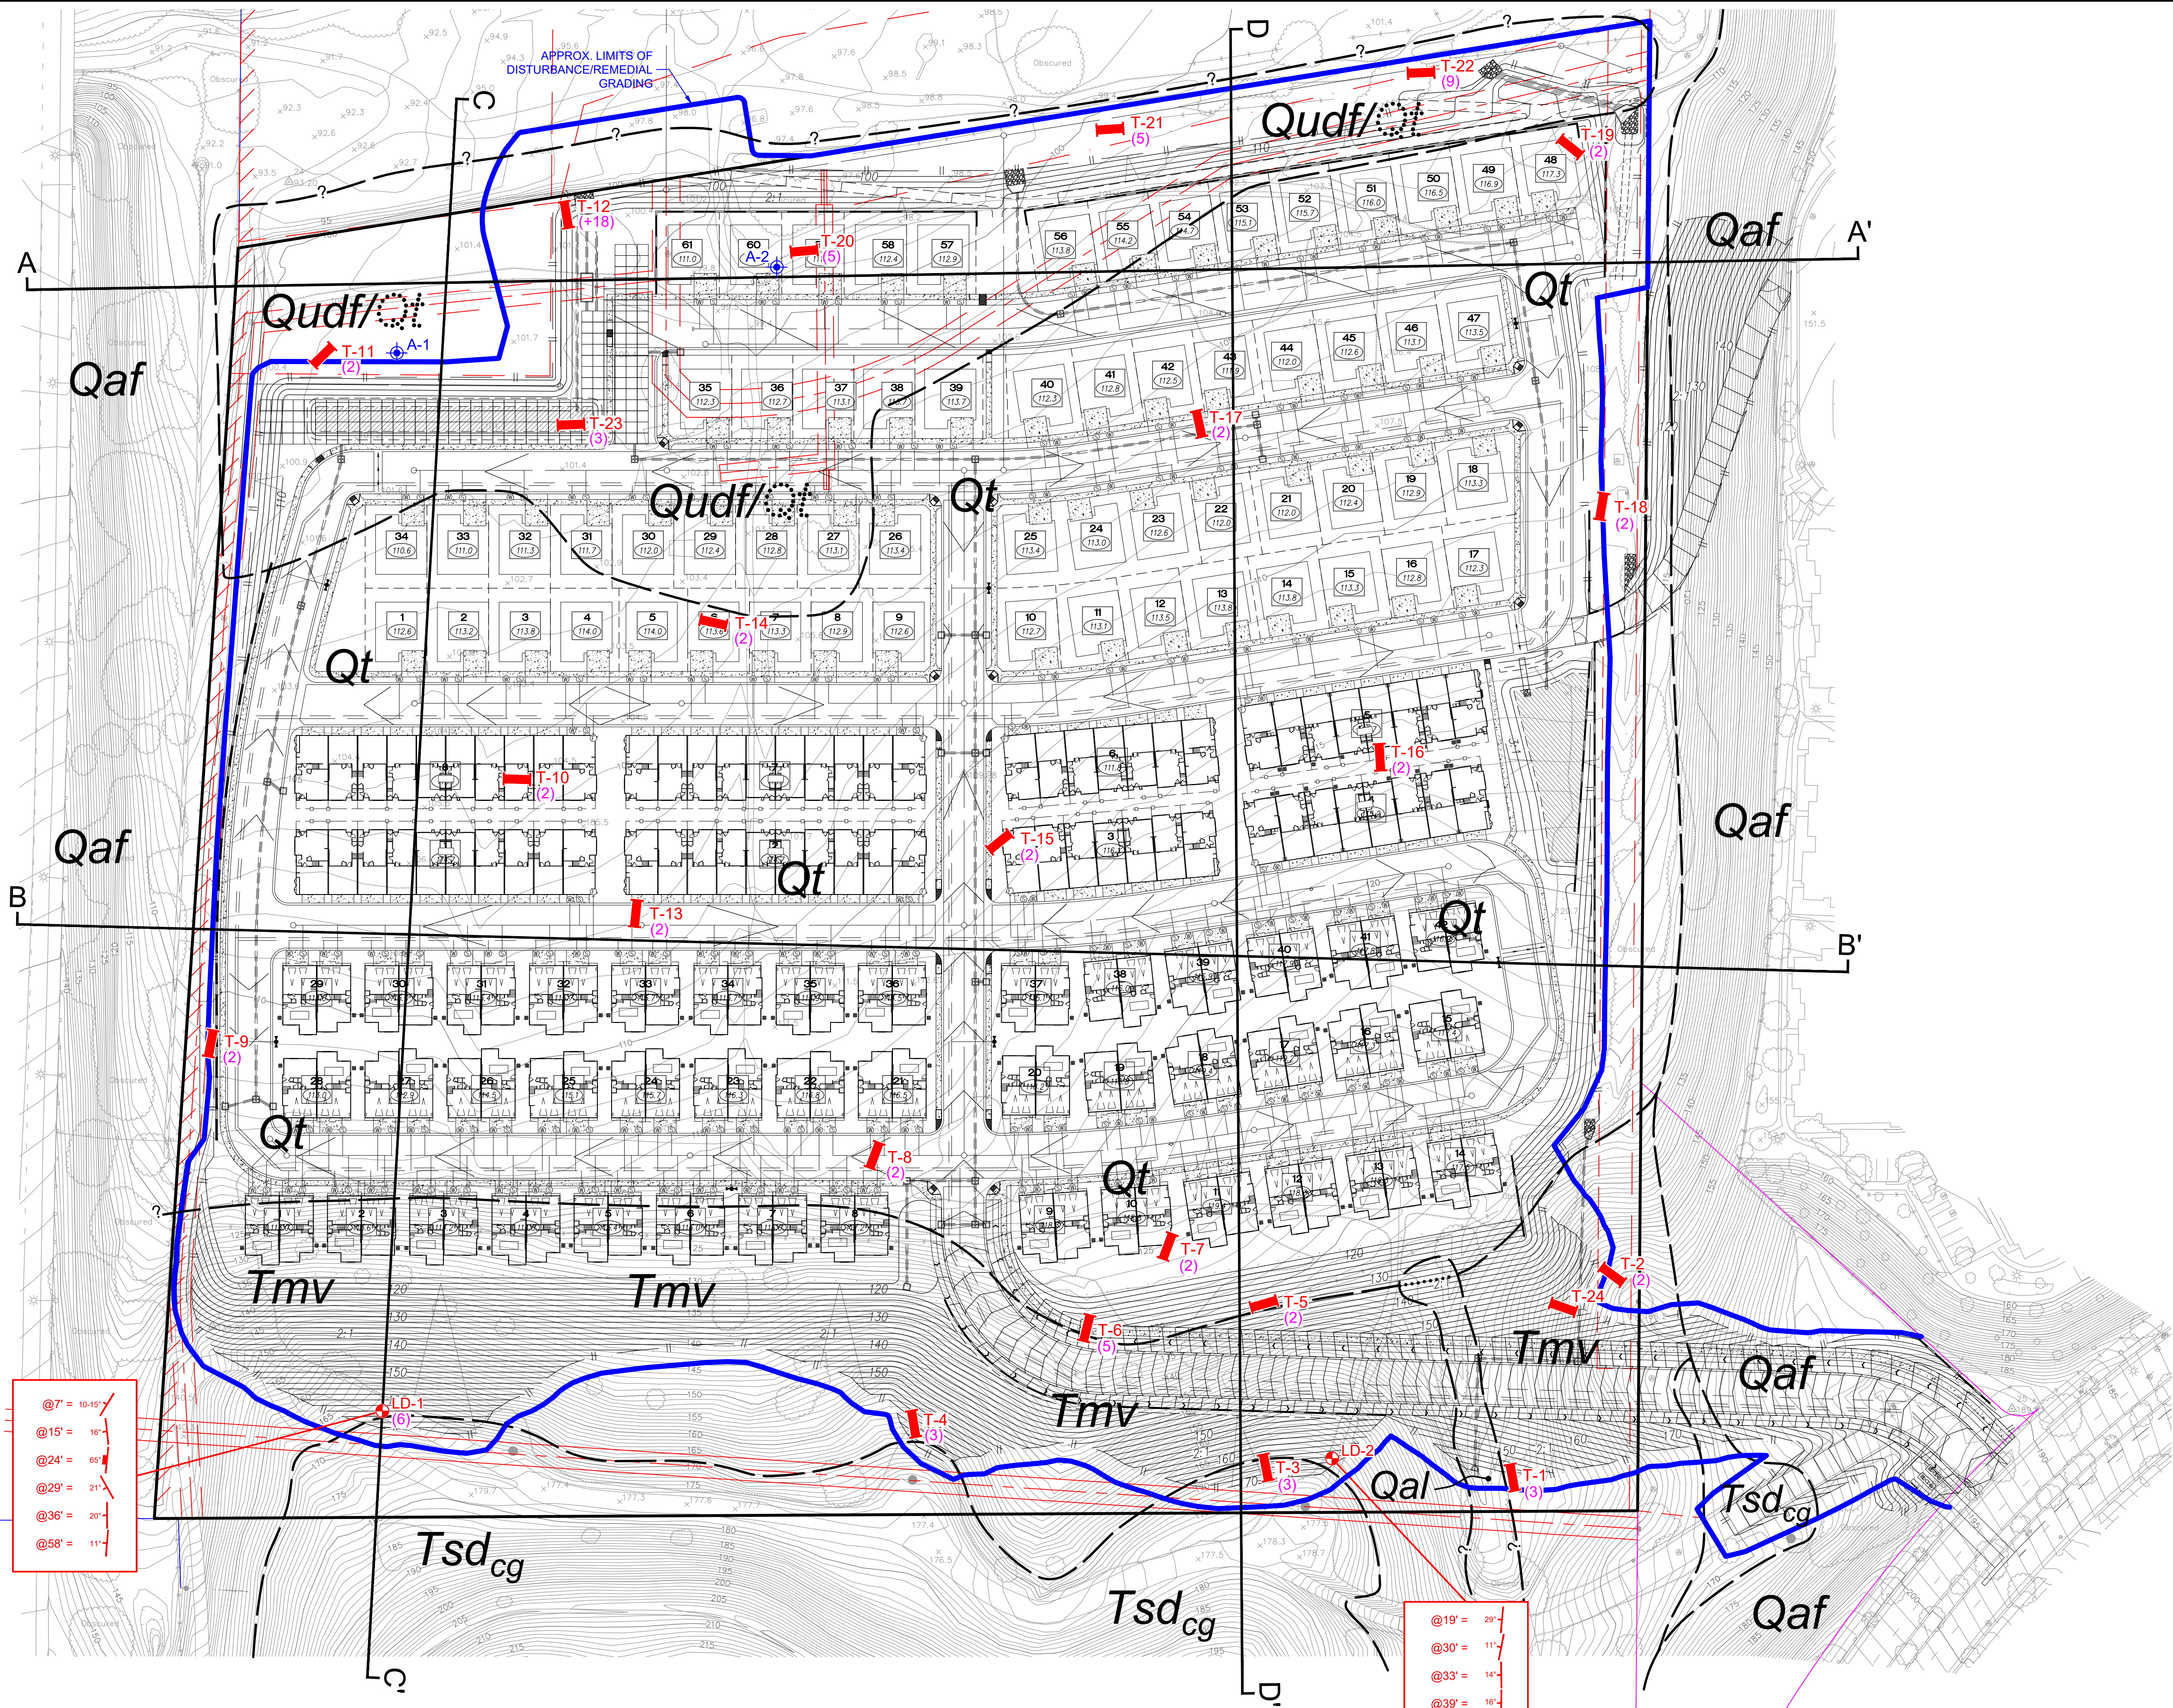
GEOCON INCORPORATED GEOTECHNICAL ■ ENVIRONMENTAL ■ MATERIALS 6940 ANDERS DRIVE, SAN DIEGO, CALIFORNIA 92121-2974 PHONE 858.558.4900 FAX 858.558.6159	SCALE 1" = 60'	DATE 02 - 09 - 2022	
	PROJECT NO. 07516 - 42 - 02	FIGURE	1
	SHEET 1 OF 1

Response: The southeast corner of the property is not underlain by a landslide. A second large diameter boring (LD-2) was drilled to a depth of 70 feet at the east end of the proposed cut slope (Figure 1 and appended boring log). The boring bottom elevation is approximately 16 feet below proposed pad grade at toe of slope. Observations made during downhole logging show similar geologic conditions to those observed in LD-1, i.e., a massive to poorly bedded very fine-grained silty sandstone dipping approximately 14 degrees due west. There are no slide planes, bedding plane shears, or other geologic features indicative of landsliding present in LD-1 or LD-2.

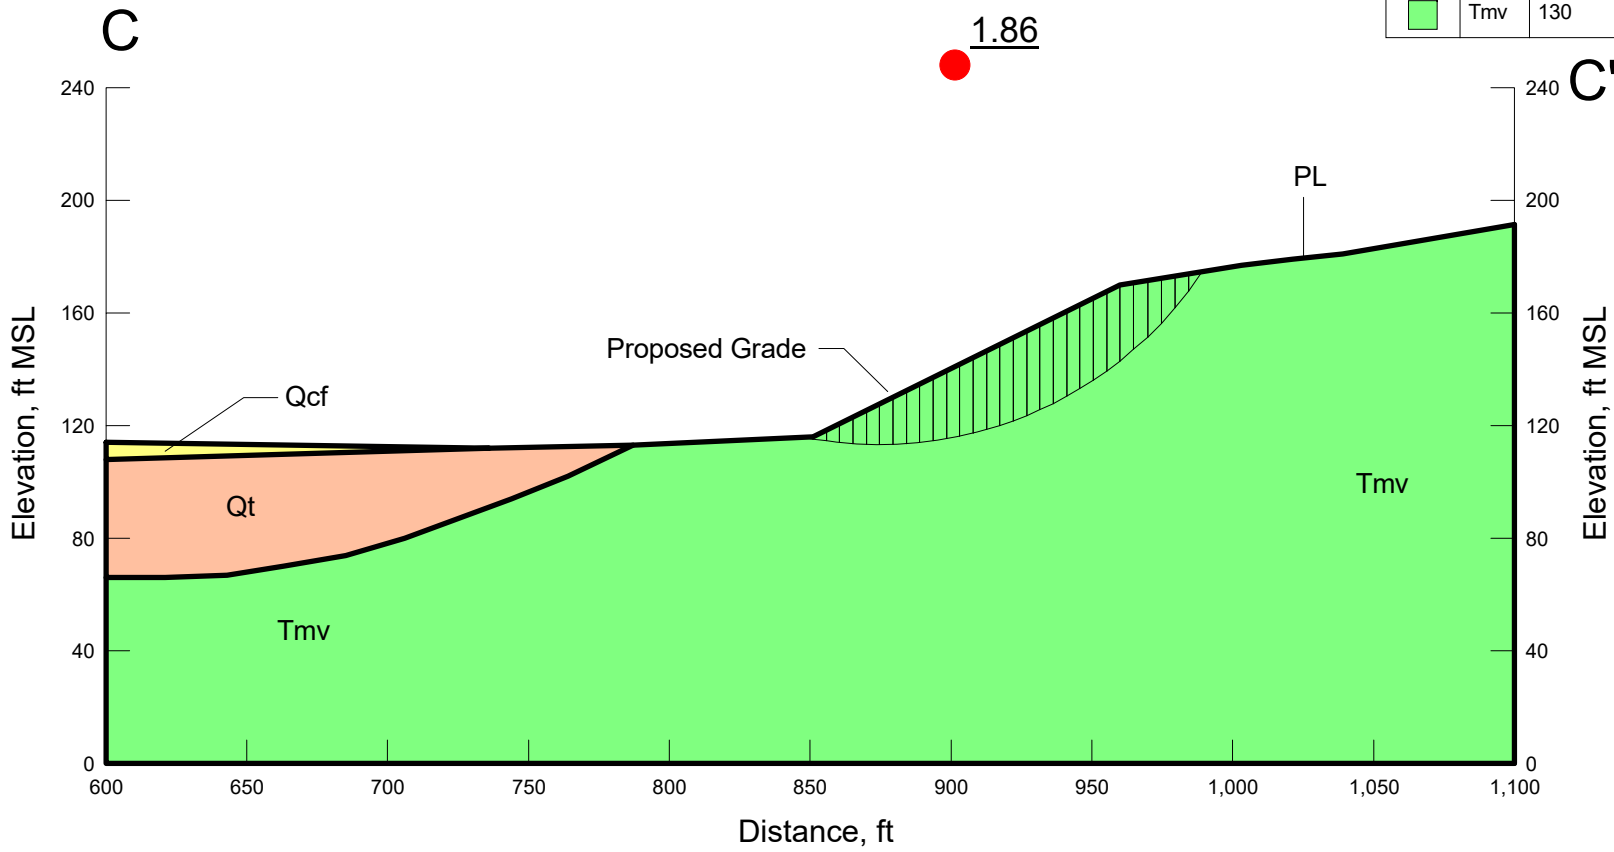
Figure 5

Using the parameters discussed herein, an equivalent site acceleration, k_{EQ} , of approximately 0.1g was calculated (see Figure 4). Using this k_{EQ} , we get a factor of safety of 1.86 for Section C-C' (see Figure 5) and 2.2 for Section D-D' (see Figure 6). A slope is considered acceptable by the screening analysis if the calculated factor of safety is greater than 1.0 using k_{EQ} ; therefore, the slopes pass the screening analysis for seismic slope stability.
