Phase I Environmental Site Assessment

Parcels 644-011-06-00 & 644-020-11-00 Olympic Parkway Chula Vista, California 91911

Geosyntec Project Number SC1029

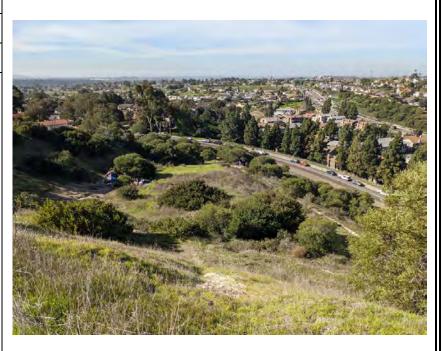
Comments: View of the adjoining property to the west, which slopes sharply down to Brandywine Avenue, beyond which are residential subdivisions. What appear to be homeless encampments were observed in the western portion of this adjoining property.

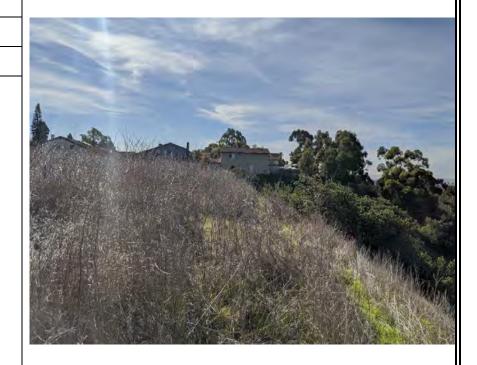
Comments: View from the southern boundary of the Site to the north. The Site is heavily vegetated in many interior portions of the Property.

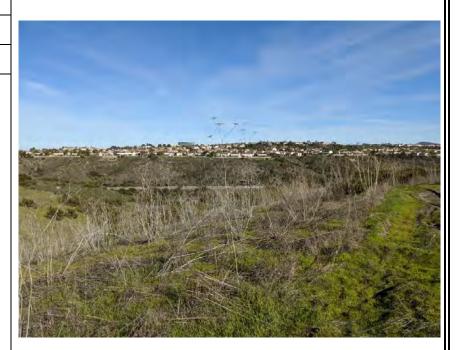
Photograph ID: 6

Comments: View of the fence line delineating the Site from the adjoining property to the South.

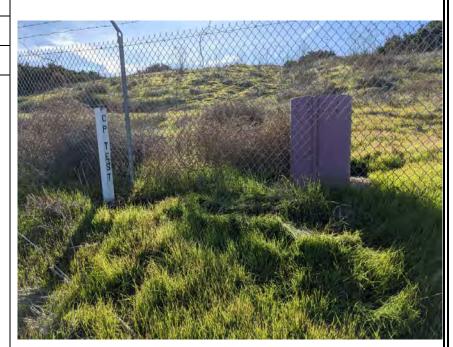
Comments: View of a monument that appears to be part of the reclaimed water line within the Site as indicated by the Owner (red, right). A location of one of the existing subsurface monitoring points is indicated by the "CP Test" marker.

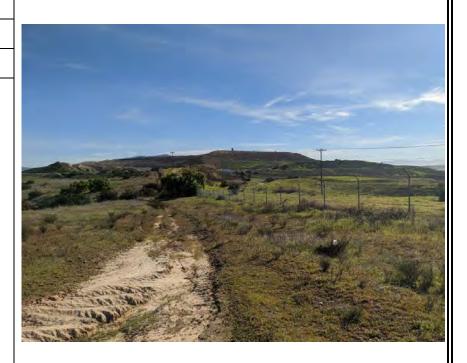
Comments: View of the southeastern portion of the Site from the southern boundary. An unimproved dirt path runs along part of the southern boundary but is eroded in several parts. Beyond the fence line is the active Otay Class III landfill.

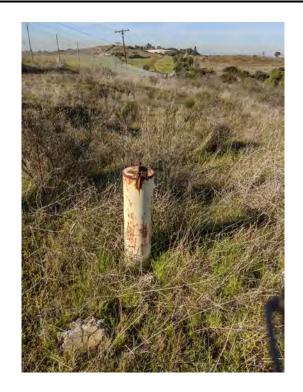
Comments: Pictured is a monitoring point vault containing a monitoring well or soil gas probe. No monitoring point label was able to be located. The vault was not able to be accessed as it was locked with a rusted lock.

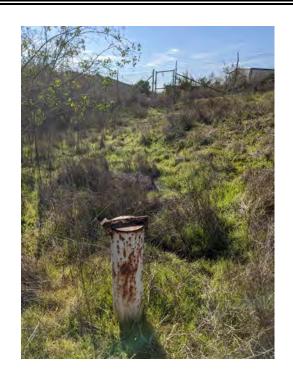
Photograph ID: 10

Comments: Pictured is a monitoring point vault containing a monitoring well or soil gas probe. No monitoring point label was able to be located. The vault was not able to be accessed as it was locked with a rusted lock.

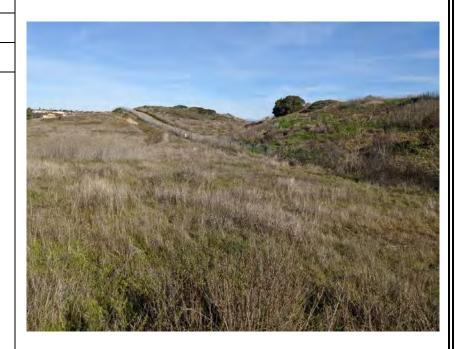
Comments: View of the eastern boundary of the Site and the western boundary of the landfill property. An unimproved dirt path runs around the corner of the Site and continues north along this eastern boundary.

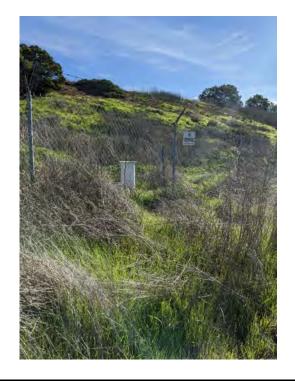
Photograph ID: 12

Comments: View of perimeter monitoring probe for the adjacent landfill. This probe appears to correspond with the location of GP-11 or GP-12 based on the Perimeter Probe Map (SCS Engineers, 2019)

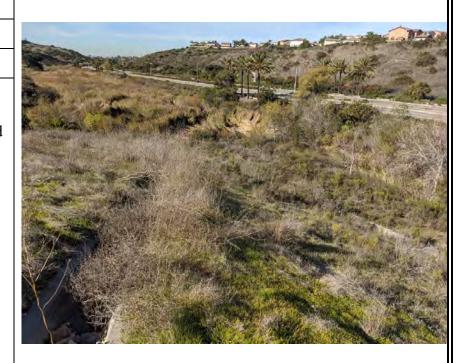
Comments: View of the northern portion of the Site containing the permitted wetland. A concrete-lined drainage ditch runs for a portion of the northern perimeter south of the wetland and empties into the wetland (shown in lower left-hand corner of the photo). The road pictured is Olympic Parkway, and residential subdivisions farther north.

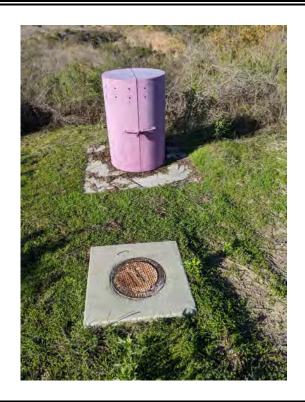
Comments: Pictured are a locked vault and manhole related to the recycled water easement owned by the Otay Water District that traverses the Site.

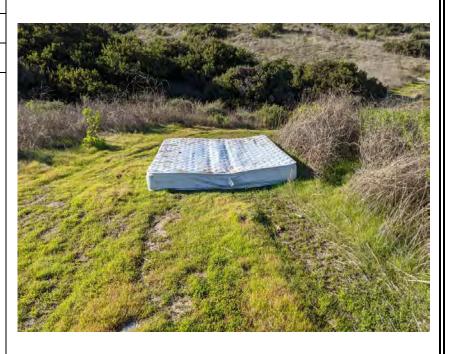
Comments: Pictured is a discarded mattress that was observed on the grass over the culvert in the center of the northern perimeter of the Site (access point from Olympic

Parkway).

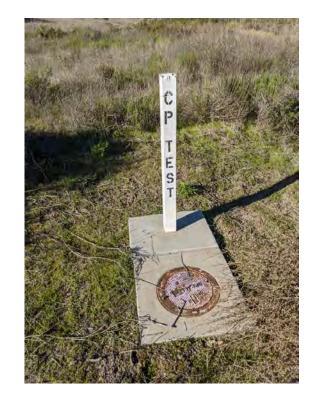
Comments: Pictured is a vault and stake labeled "CP Test" related to an onsite monitoring feature.

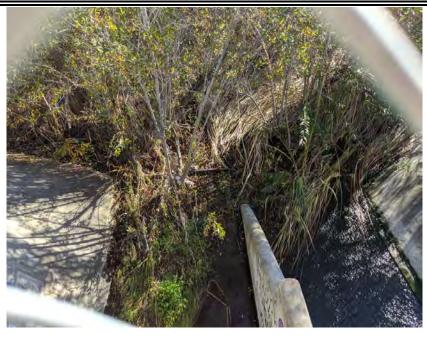
Photograph ID: 18

Comments: Pictured is the upstream side of one of the culverts present along the northern boundary of the Site. This waterway in the northern portion of the Site was heavily vegetated and water was flowing at the time of the Site visit.

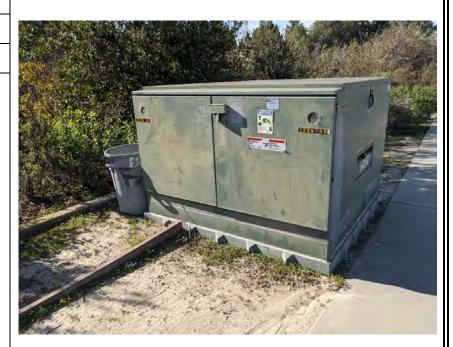
Comments: Pictured is an electrical transformer between the northeastern corner of the Site and the sidewalk that runs outside the northern perimeter of the Site. No spills or staining were observed around the transformer, and no PCB stickers were observed.

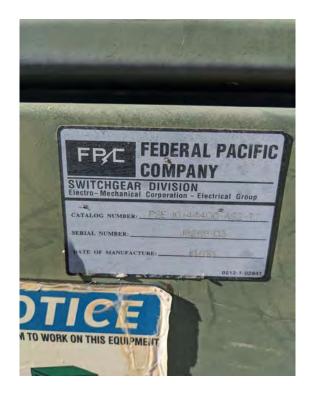
Comments: Pictured is the label on the transformer described in Photo 19.
