**UPDATE
GEOTECHNICAL REPORT**

**OTAY RANCH VILLAGE 8 EAST
CHULA VISTA, CALIFORNIA**

**PROJECT NO. G1006-52-05
SEPTEMBER 30, 2022
REVISED MAY 5, 2023**

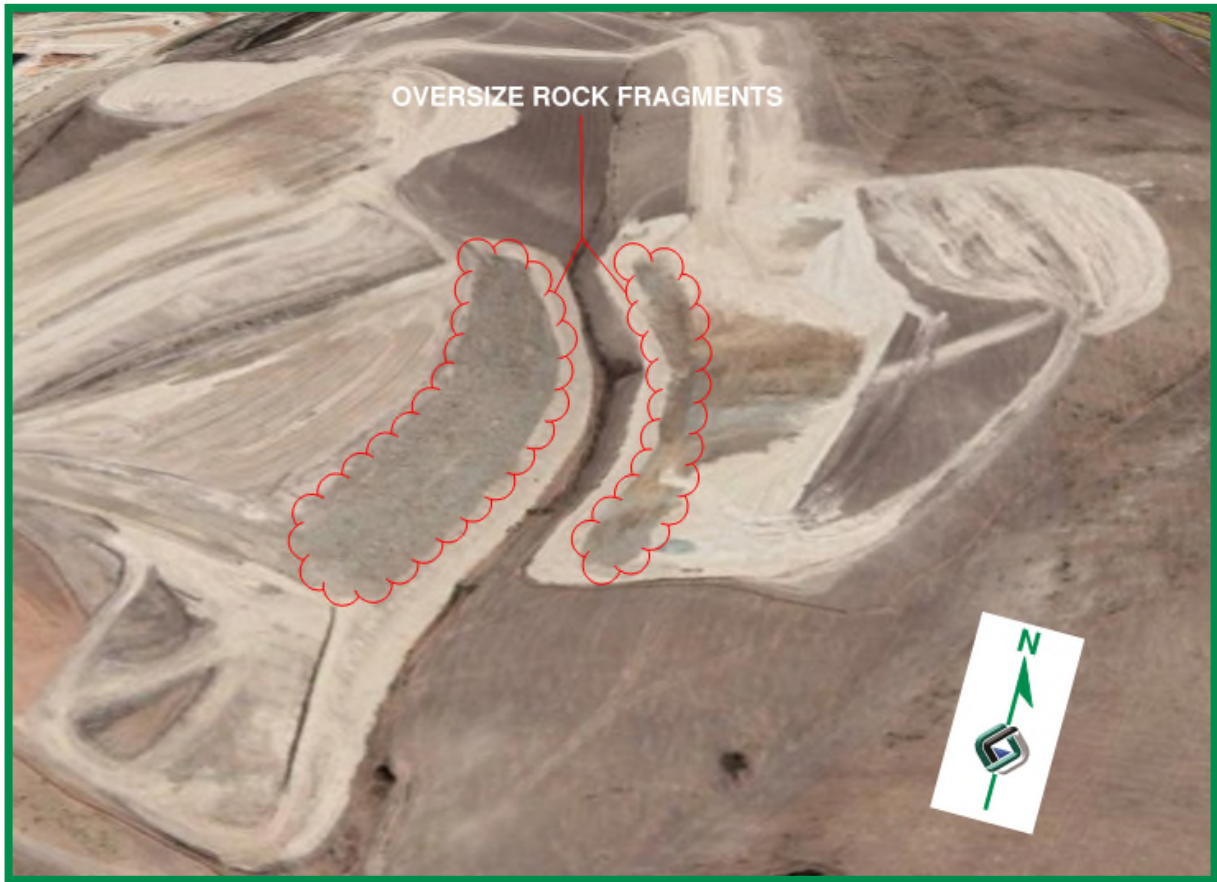
Existing Site Plan

During the disposal site grading operations, the contractor constructed temporary fill slopes with a maximum height of approximately 35 feet at inclinations of 2:1 (horizontal to vertical) or flatter. The existing site conditions and approximate oversize rock fragments are presented on the Existing Site Plan.

After remedial grading of the surficial soil and installation of toe drains, the western and eastern facing embankment fill slopes were constructed along the margins of a shallow alluvial drainage. At the direction of Terra Development Inc. and HomeFed, the contractor extended the soil-rock fill to the temporary slope face instead of placing finer-grained compacted fill materials for placement on the outer slope face as outlined in our letters dated October 9, 2020, and July 15, 2021. Although the contractor properly placed the soil-rock fill, the slope surface areas of the soil-rock fill possess voids between the rock fragments that will require additional remedial grading during future grading operations. Some oversize rock will require special handling and benching techniques prior to additional fill placement.

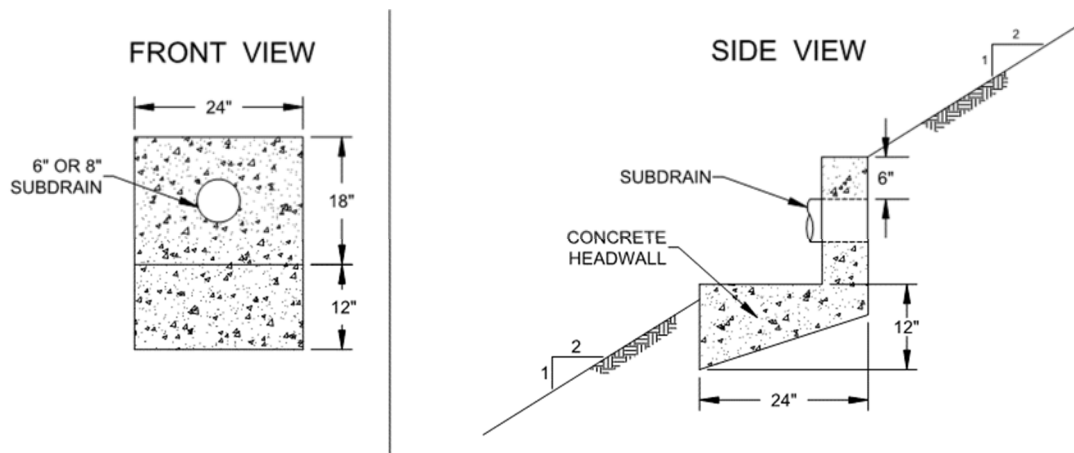
Typical Headwall Detail

11.7.4 Subdrains that discharge into a natural drainage course or open space area should be provided with a permanent headwall structure as shown herein.

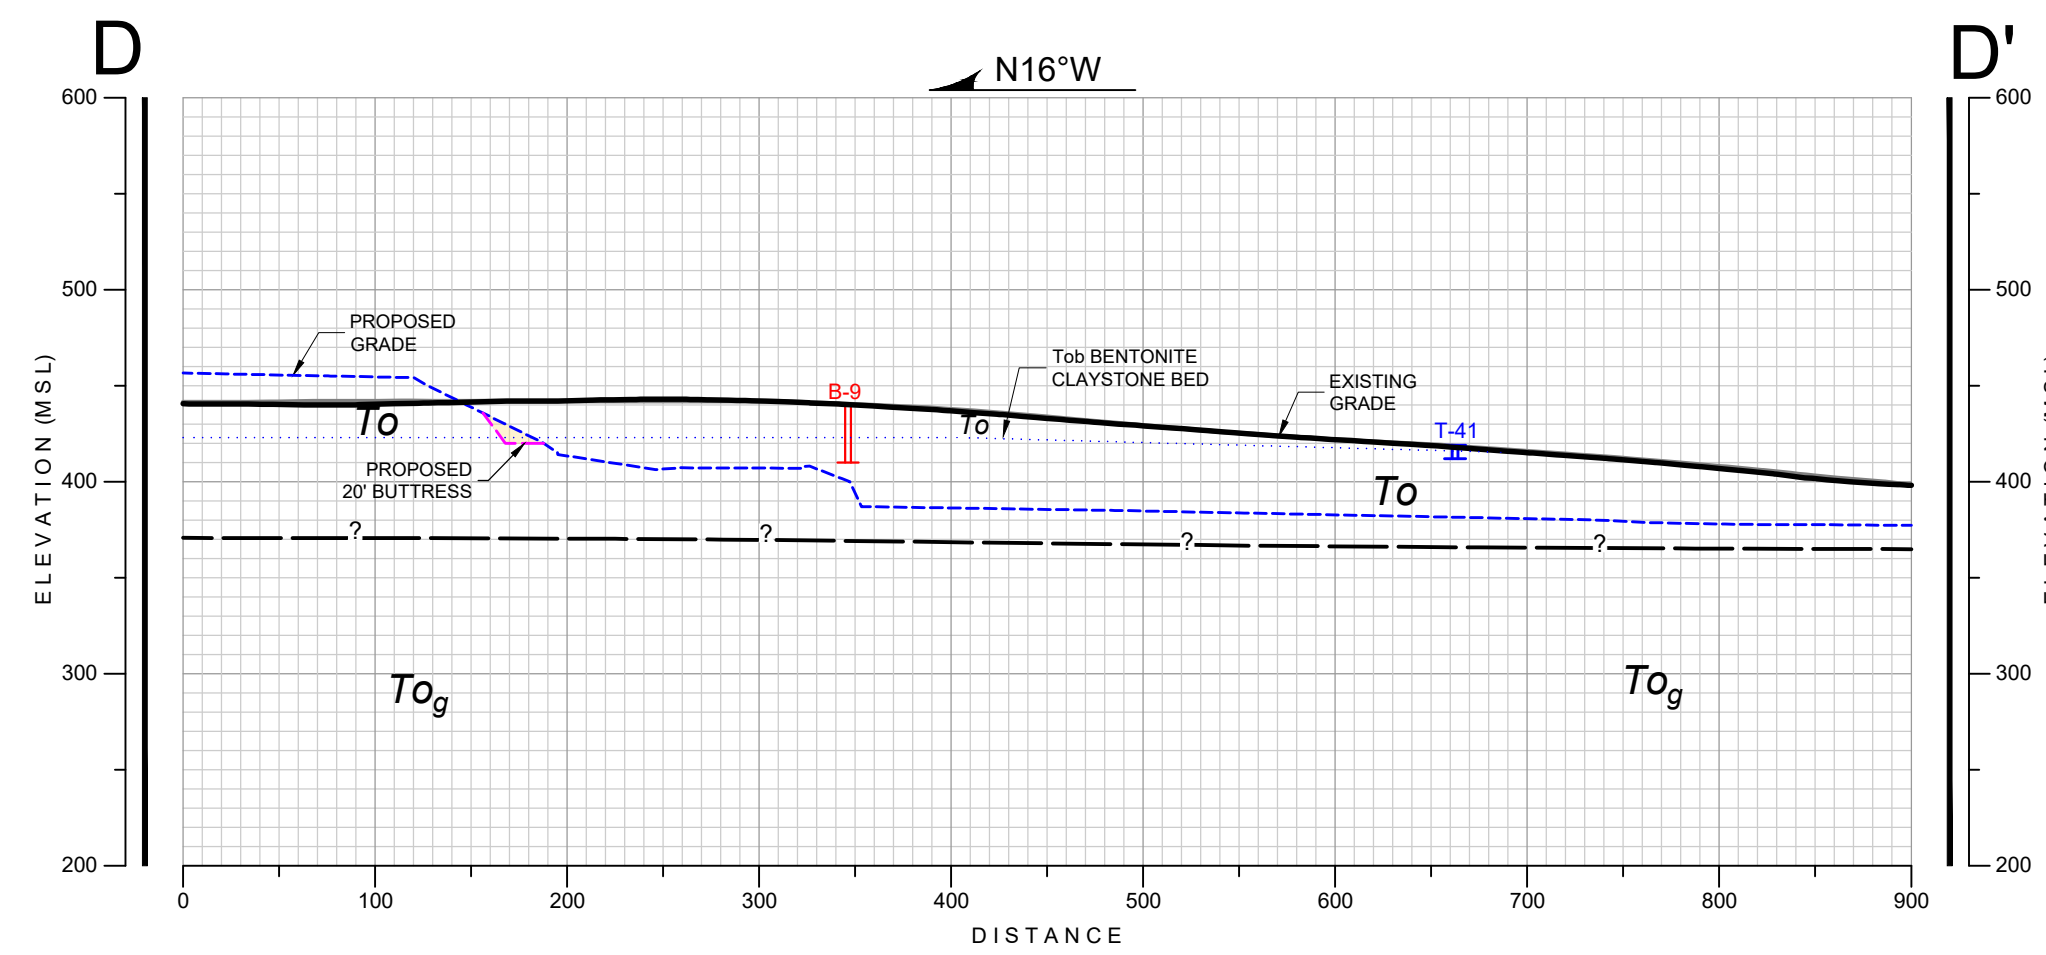
GEOLOGIC CROSS-SECTION D-D'
SCALE: 1" = 100' (Vert. = Horiz.)

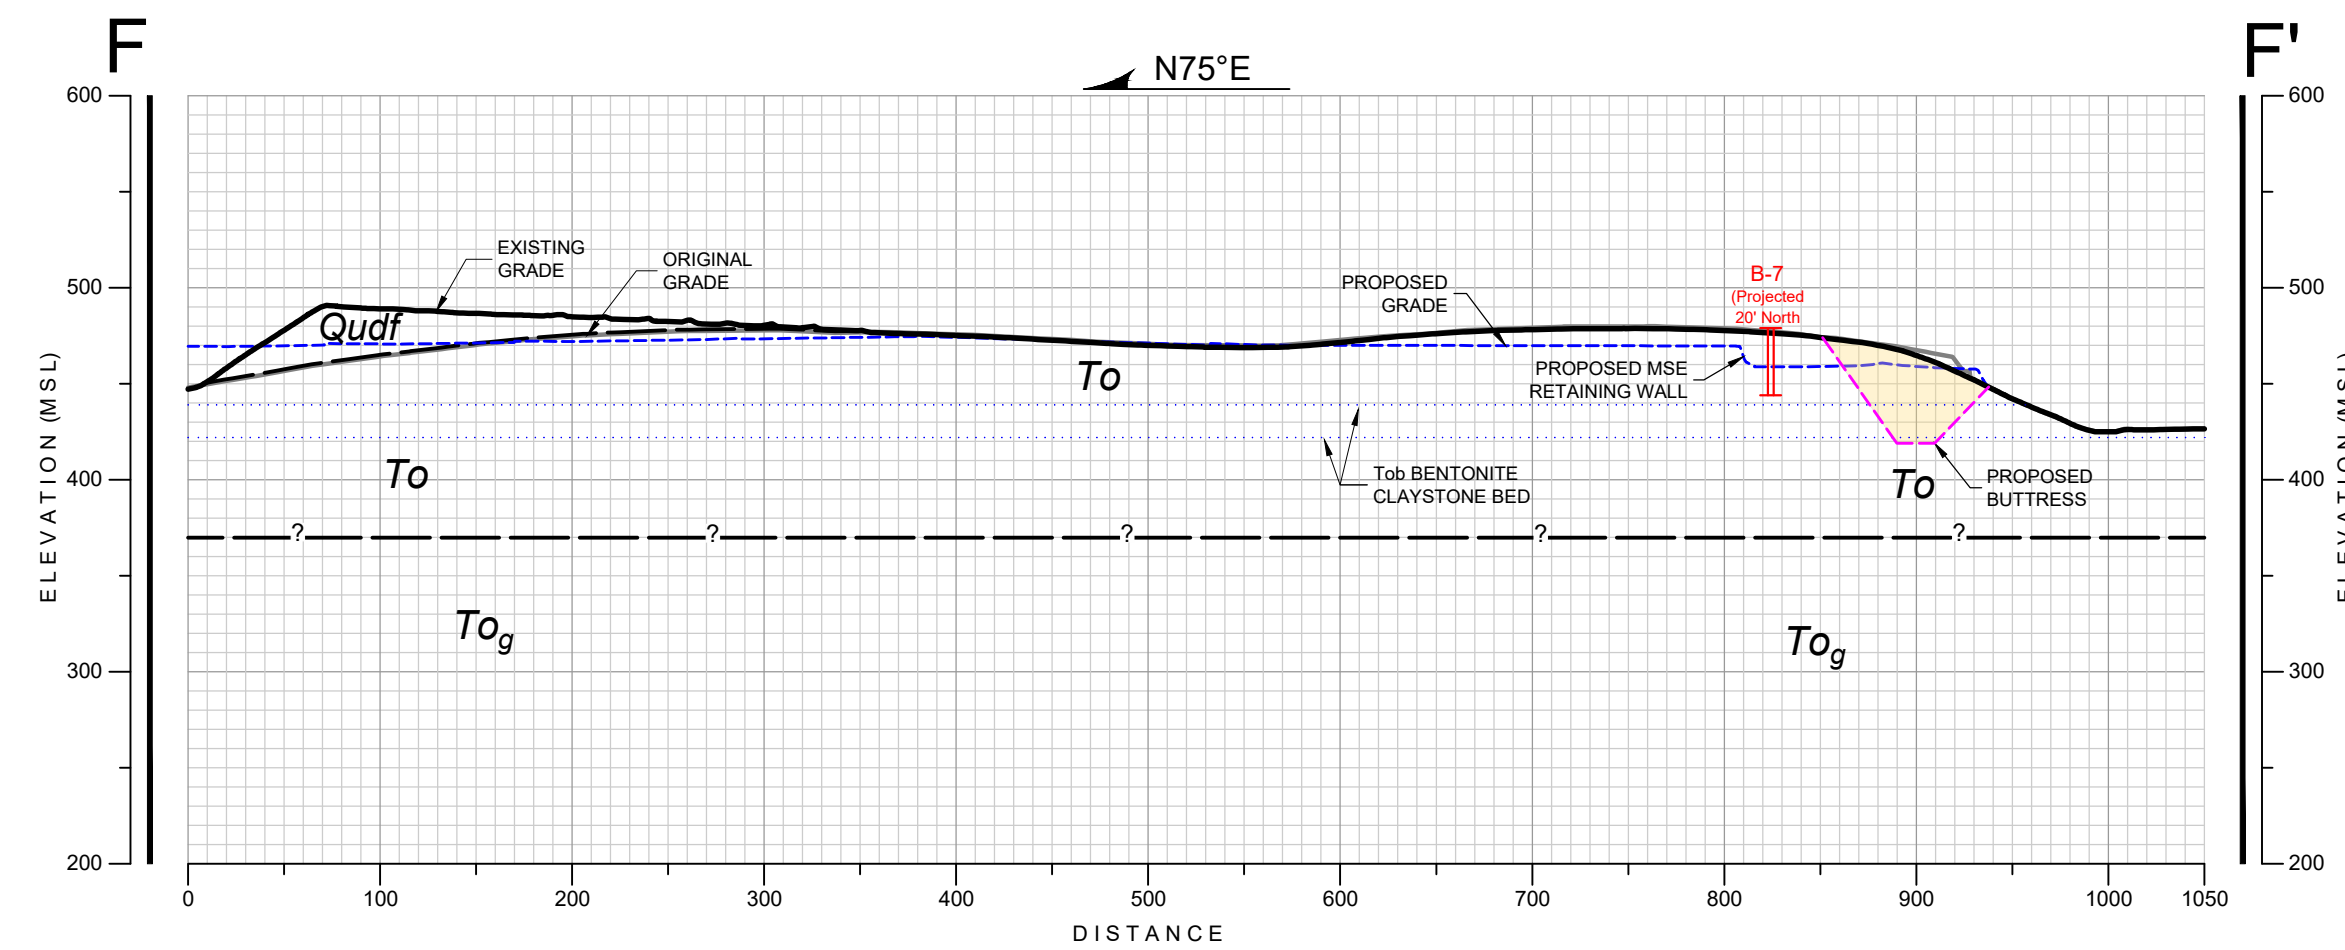
GEOLOGIC CROSS-SECTION F-F'
SCALE: 1" = 100' (Vert. = Horiz.)

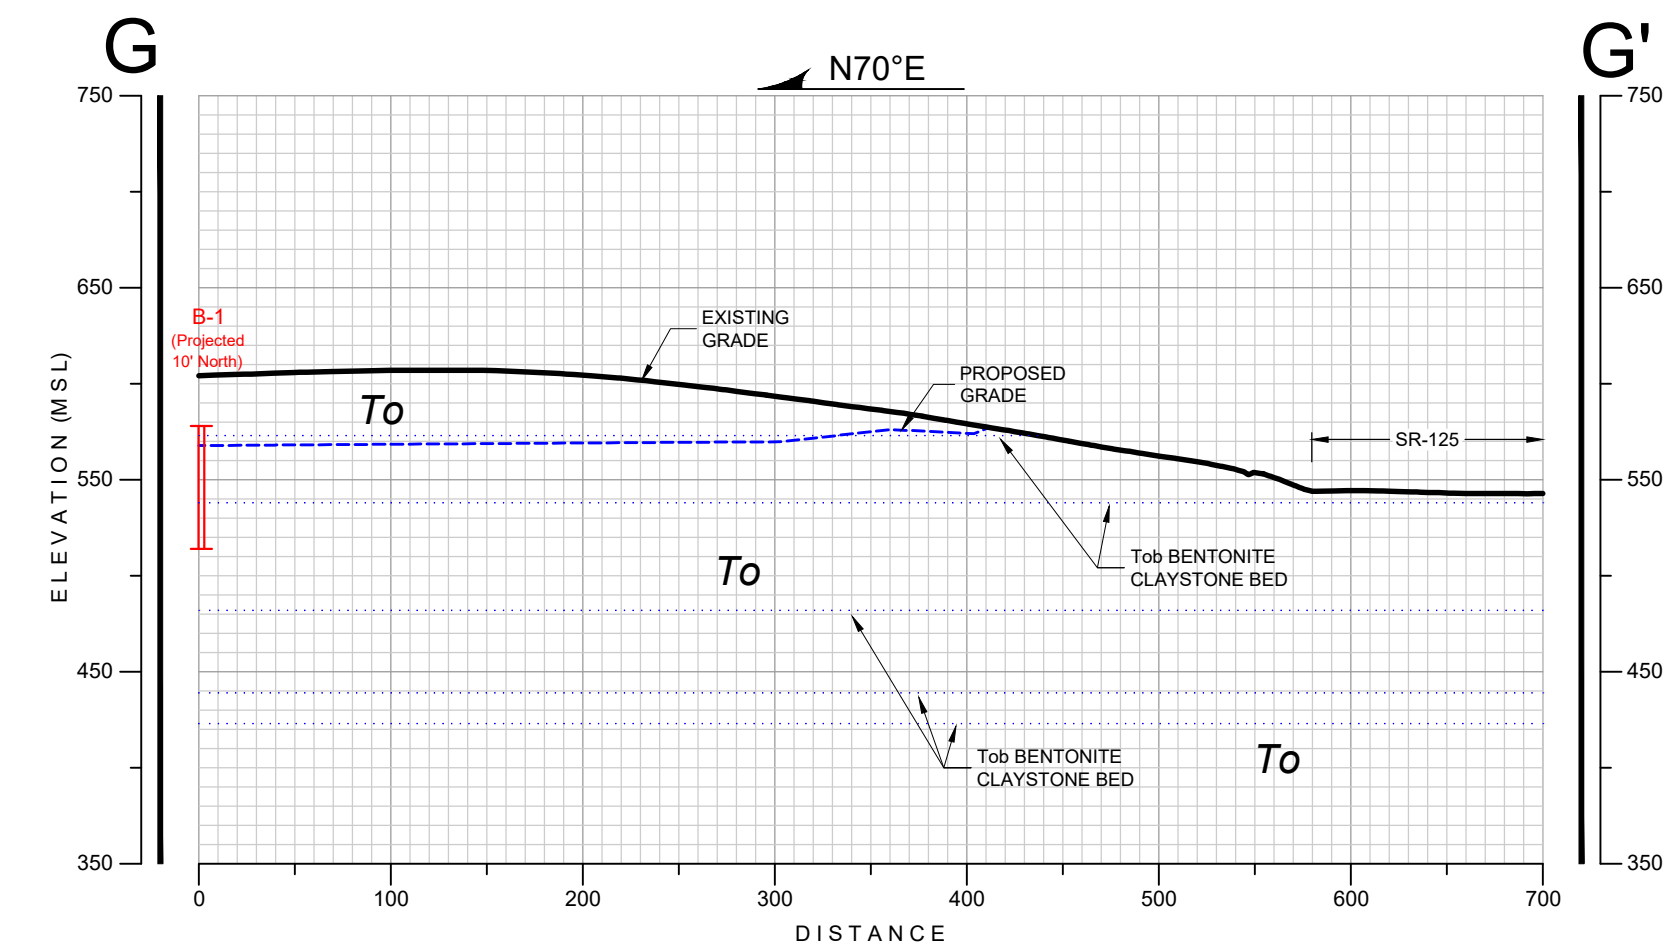
GEOLOGIC CROSS-SECTION G-G'
SCALE: 1" = 100' (Vert. = Horiz.)

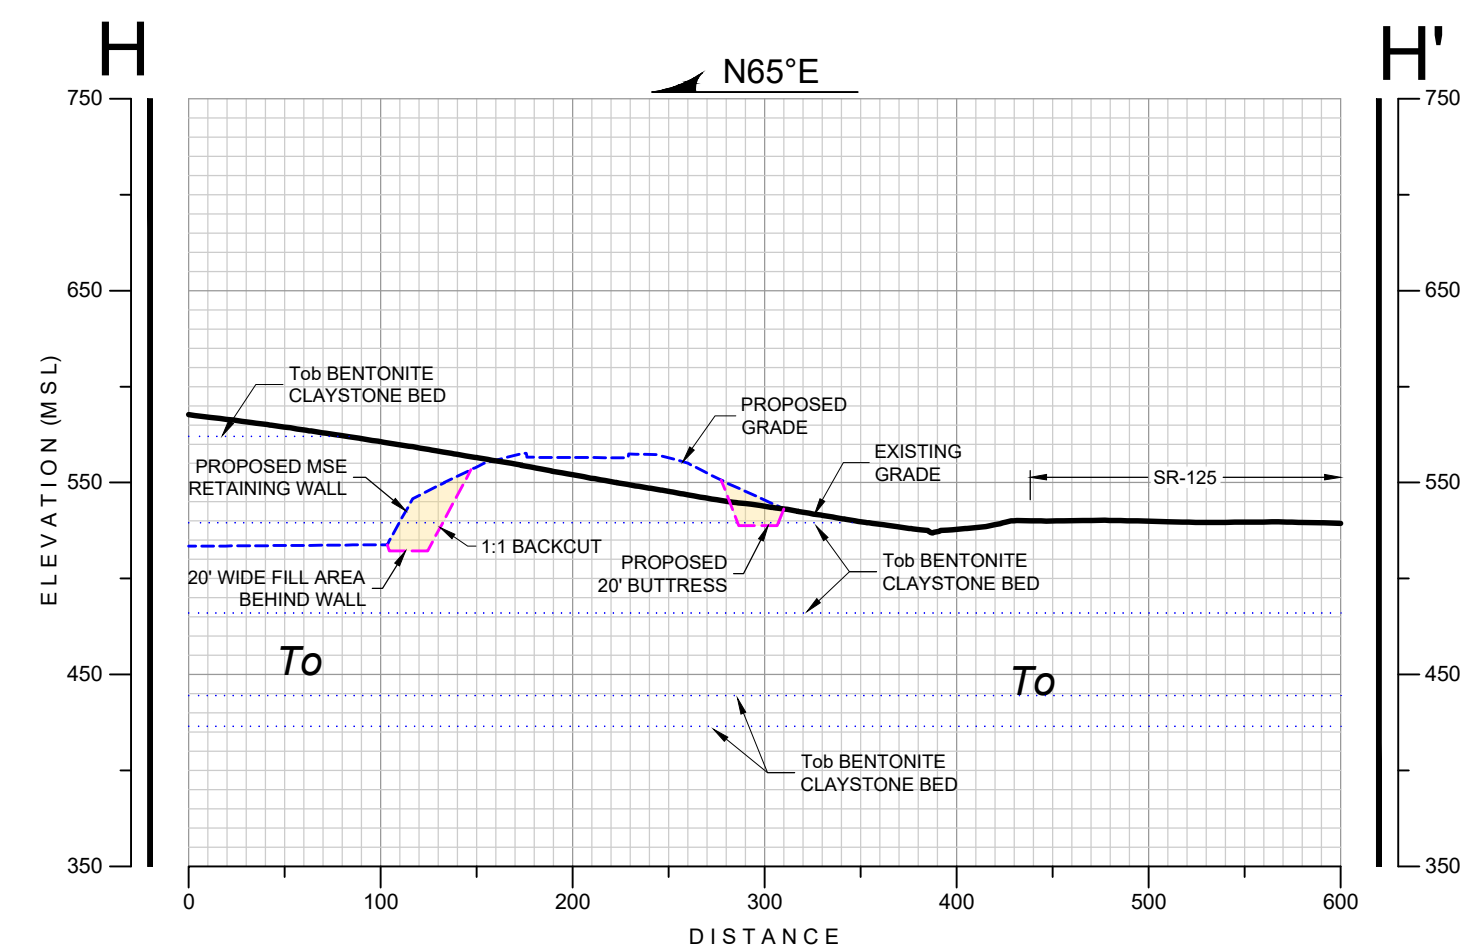
GEOLOGIC CROSS-SECTION H-H'
SCALE: 1" = 100' (Vert. = Horiz.)

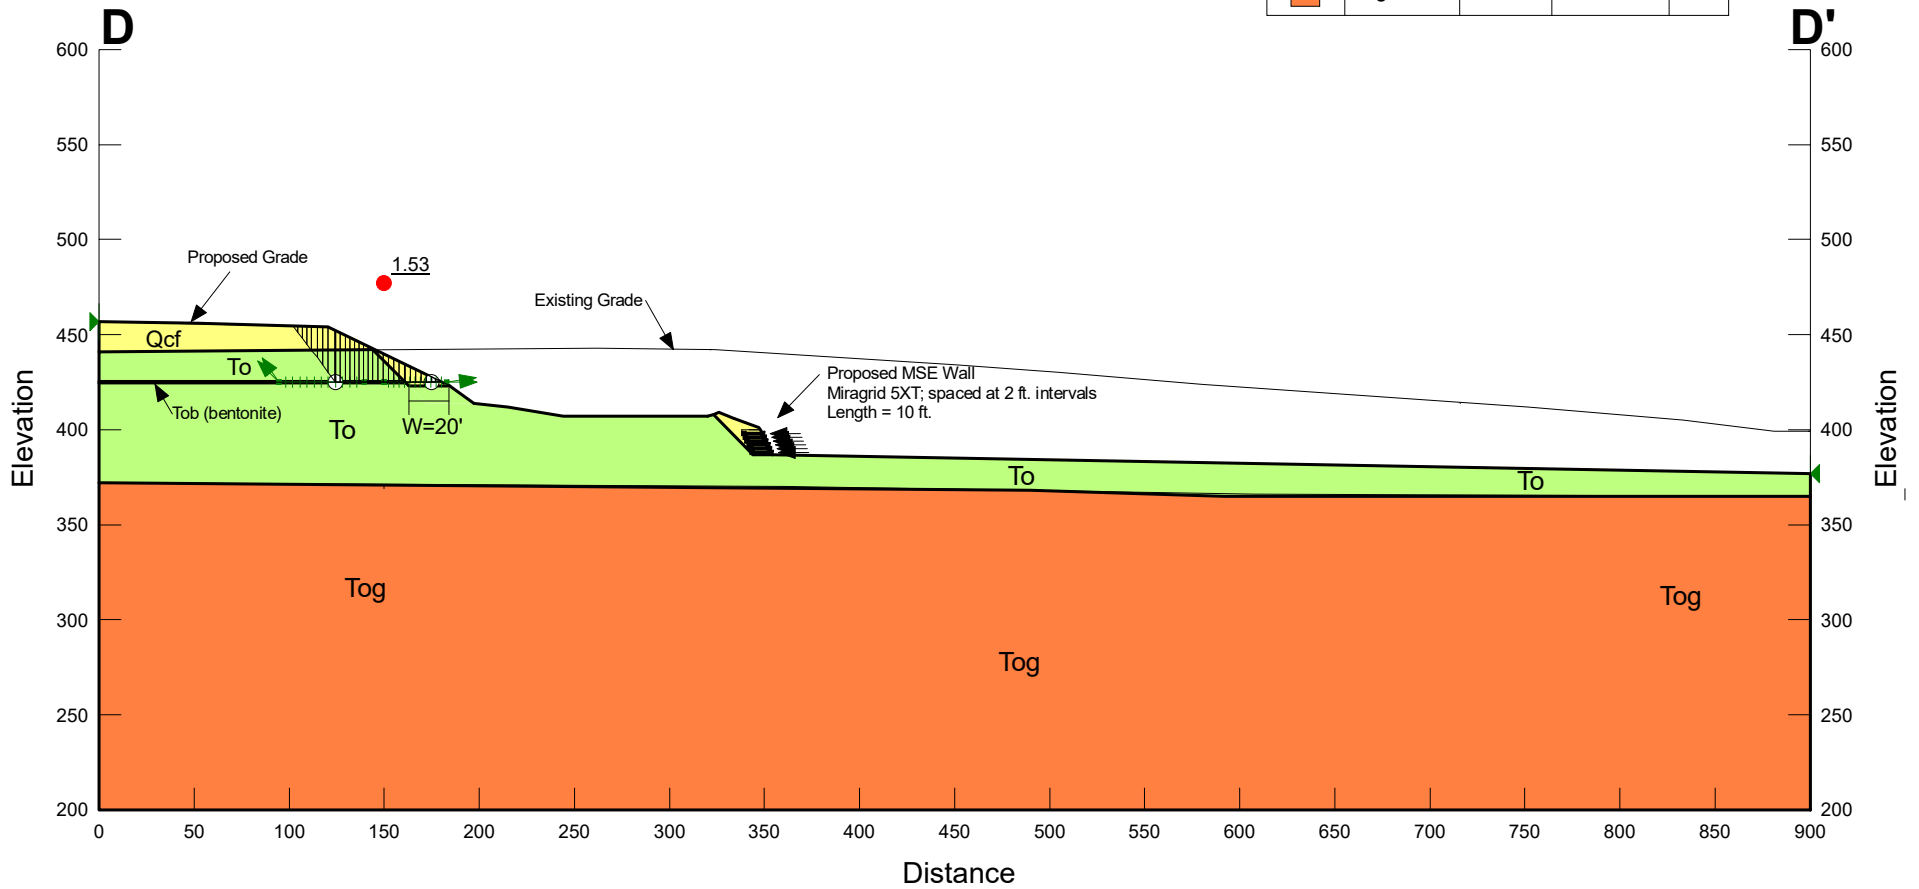
Project Name: Otay Ranch Village 8
 Project No. G1006-52-05
 Section D-D'
 File Name: D-D'_Case 3.gsz
 Date: 09/27/2022, Time: 02:53:15 PM

Proposed Grade
 Static Condition
 Block-mode Analysis Along Bentonite
 w/ 20 ft. Buttress

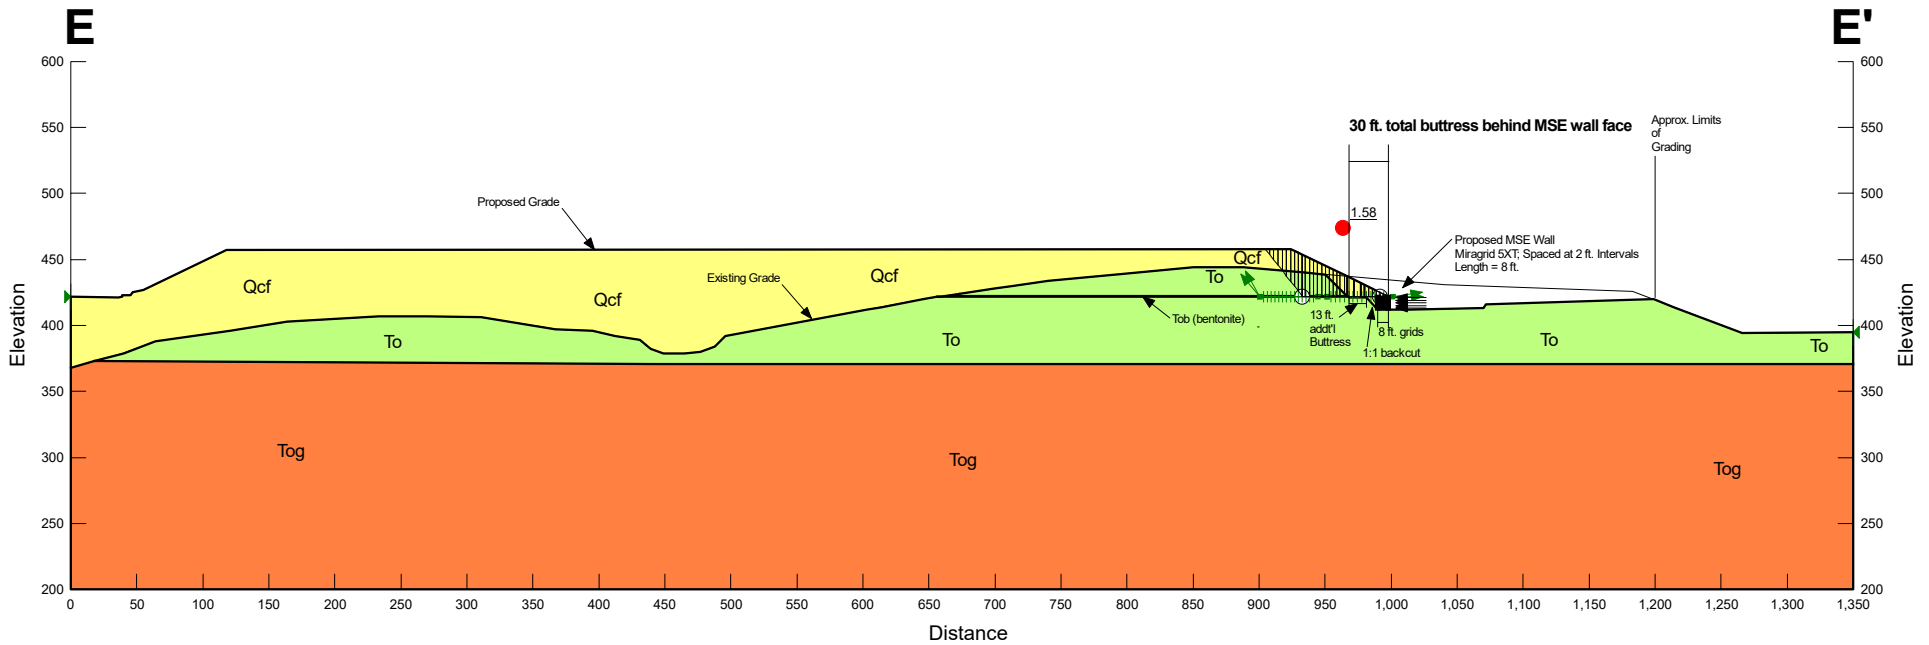
Project Name: Otay Ranch Village 8
 Project No. G1006-52-05
 Section E-E'
 File Name: E-E'_Case3.gsz
 Date: 09/27/2022, Time: 03:05:27 PM

Proposed Grade
 Static Condition
 Rotational-mode Analysis
 w/ 30 ft. Wide Total Buttress (benched cut)

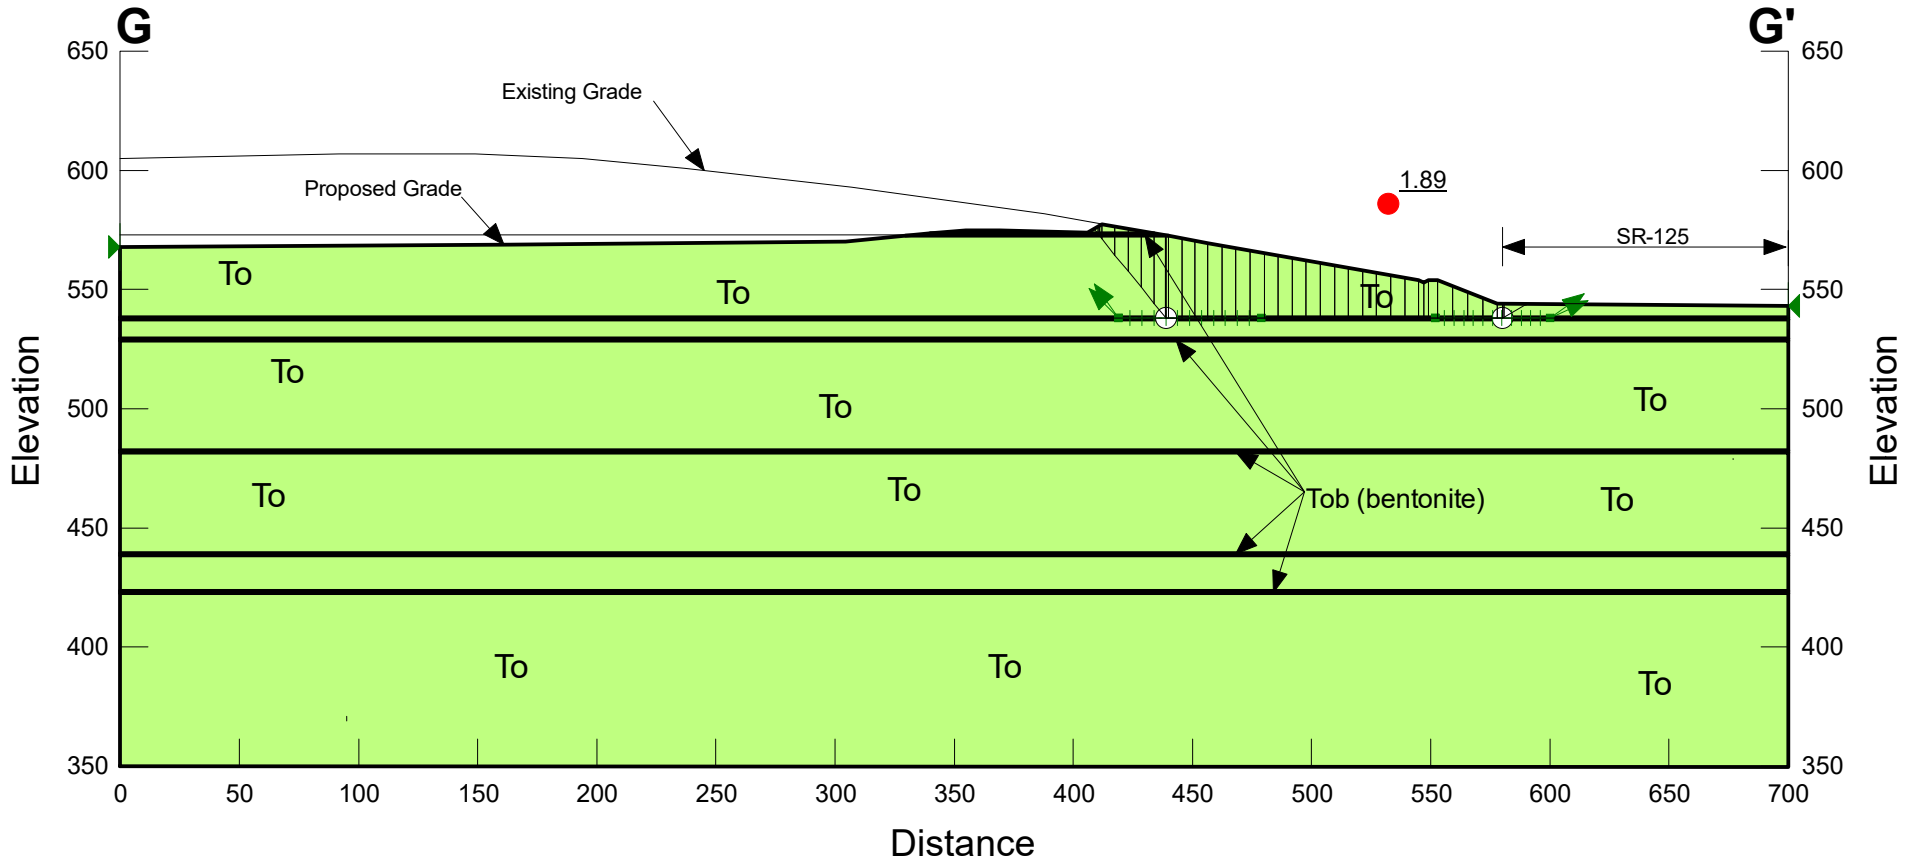
Color	Name	Unit Weight (pcf)	Cohesion' (psf)	Phi' (°)
	To	130	350	34
	Tob (bentonite)	120	30	6

Proposed Grade
 Static Condition
 Block-mode Analysis Along Bentonite Layer

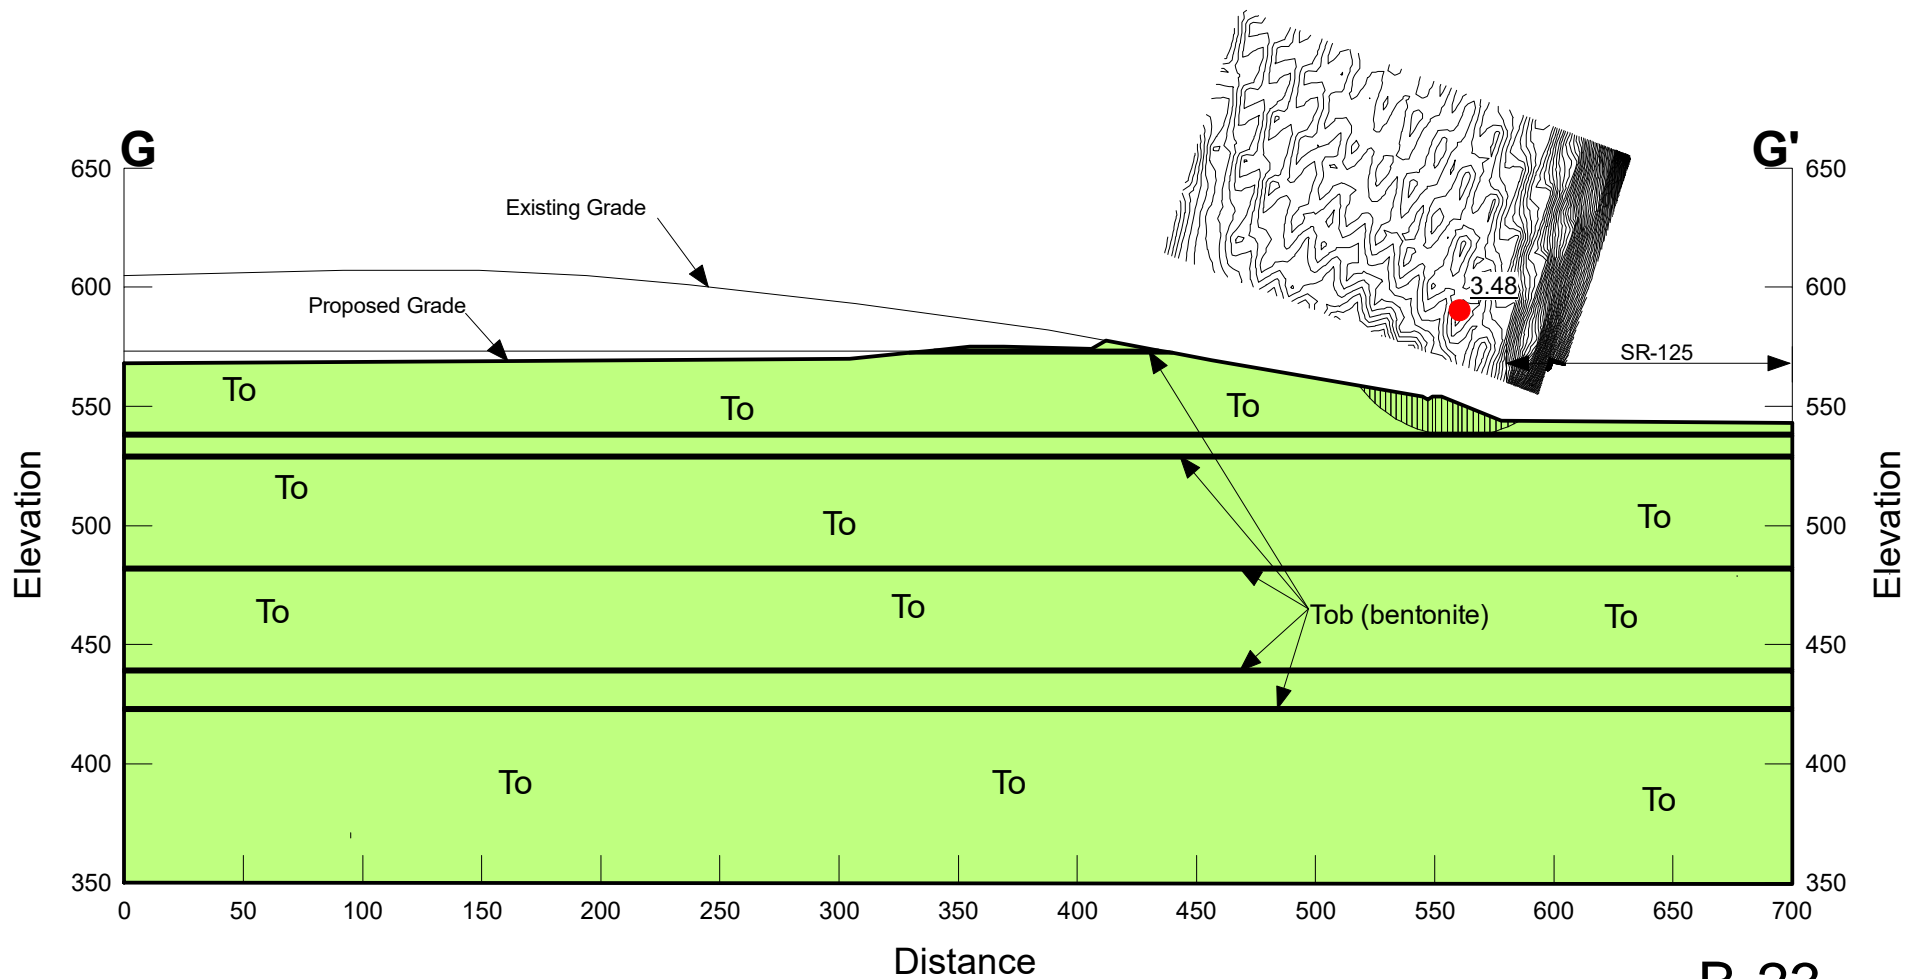
Project Name: Otay Ranch Village 8
 Project No. G1006-52-05
 Section G-G'
 File Name: G-G'_Case2.gsz
 Date: 09/26/2022, Time: 01:32:18 PM

Proposed Grade
 Static Condition
 Rotational-mode Analysis

Color	Name	Unit Weight (pcf)	Cohesion' (psf)	Phi' (°)
	To	130	350	34
	Tob (bentonite)	120	30	6

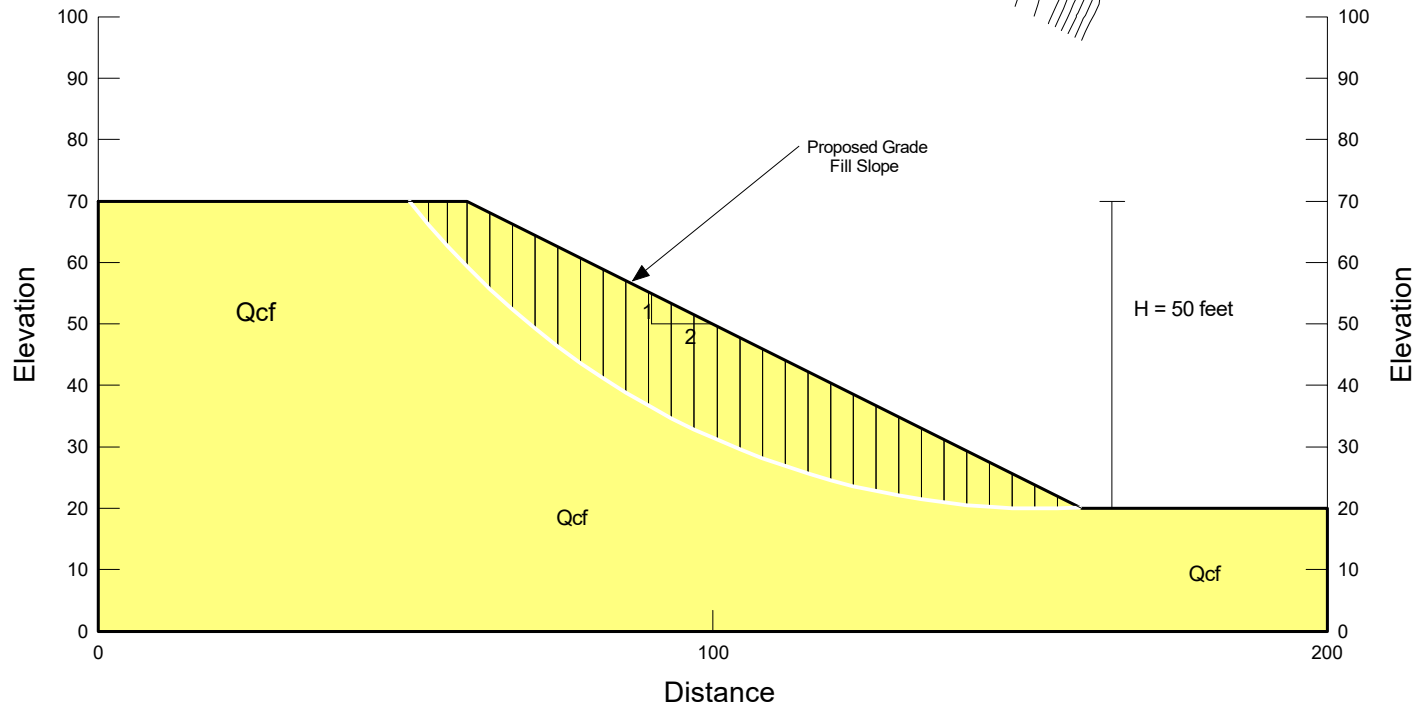
File Name: Fill Slope H=50.gsz
 Date: 09/28/2022, Time: 09:44:14 PM

Color	Name	Unit Weight (pcf)	Cohesion' (psf)	Phi' (°)
	Qcf	125	250	28

50 ft. High Fill Slope

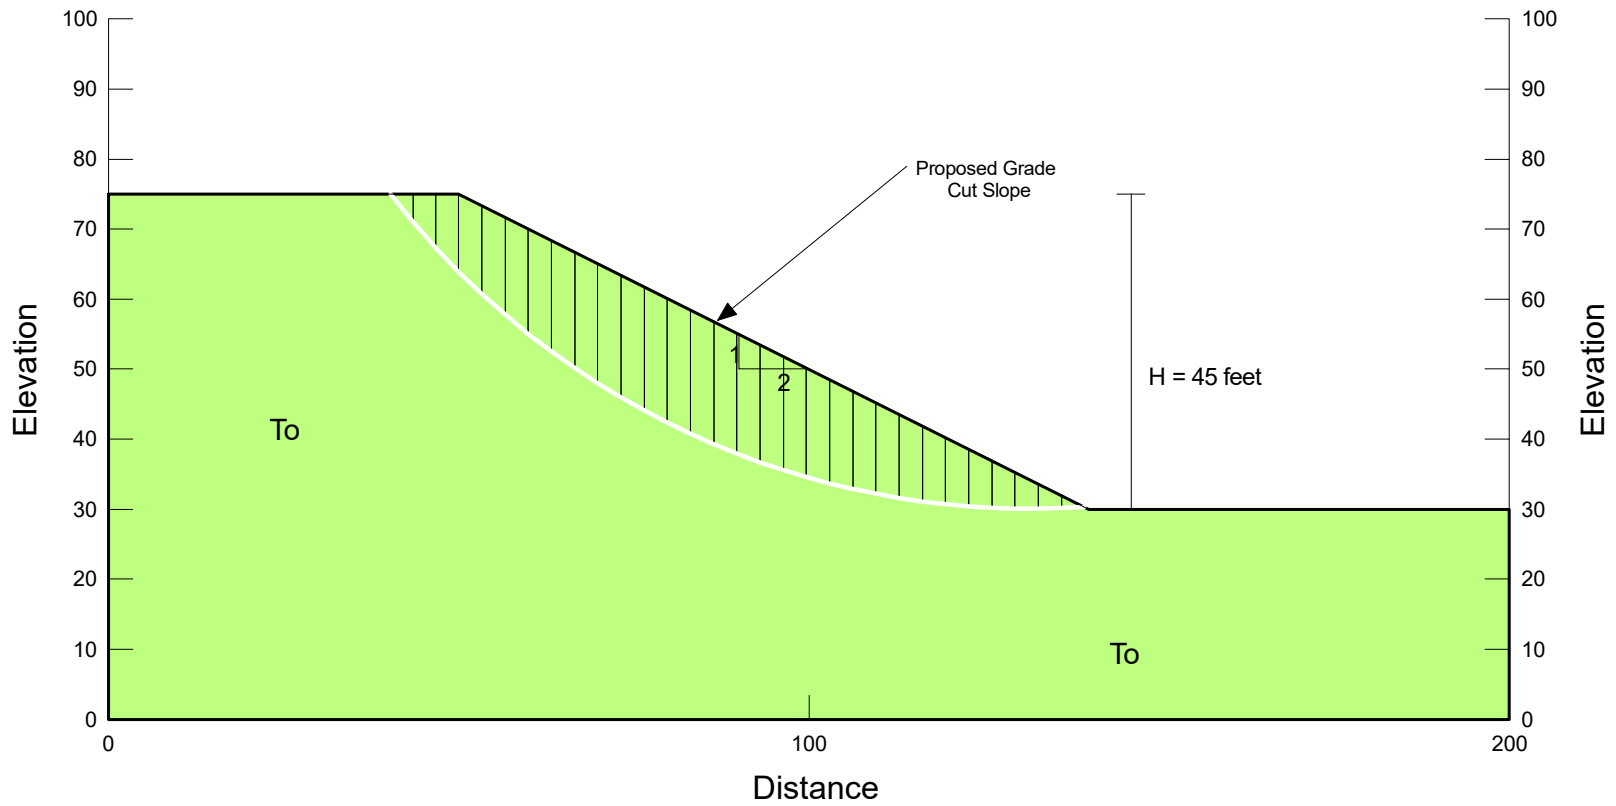
File Name: Cut Slope H=45.gsz
 Date: 09/28/2022, Time: 09:51:43 PM

Color	Name	Unit Weight (pcf)	Cohesion' (psf)	Phi' (°)
	To	130	350	34

45 ft. High Cut Slope
