**INFILTRATION  
FEASIBILITY CONDITION LETTER**

**NAKANO  
CHULA VISTA, CALIFORNIA**

**GEOCON**  
INCORPORATED

**APRIL 21, 2023  
PROJECT NO. 07516-42-02**

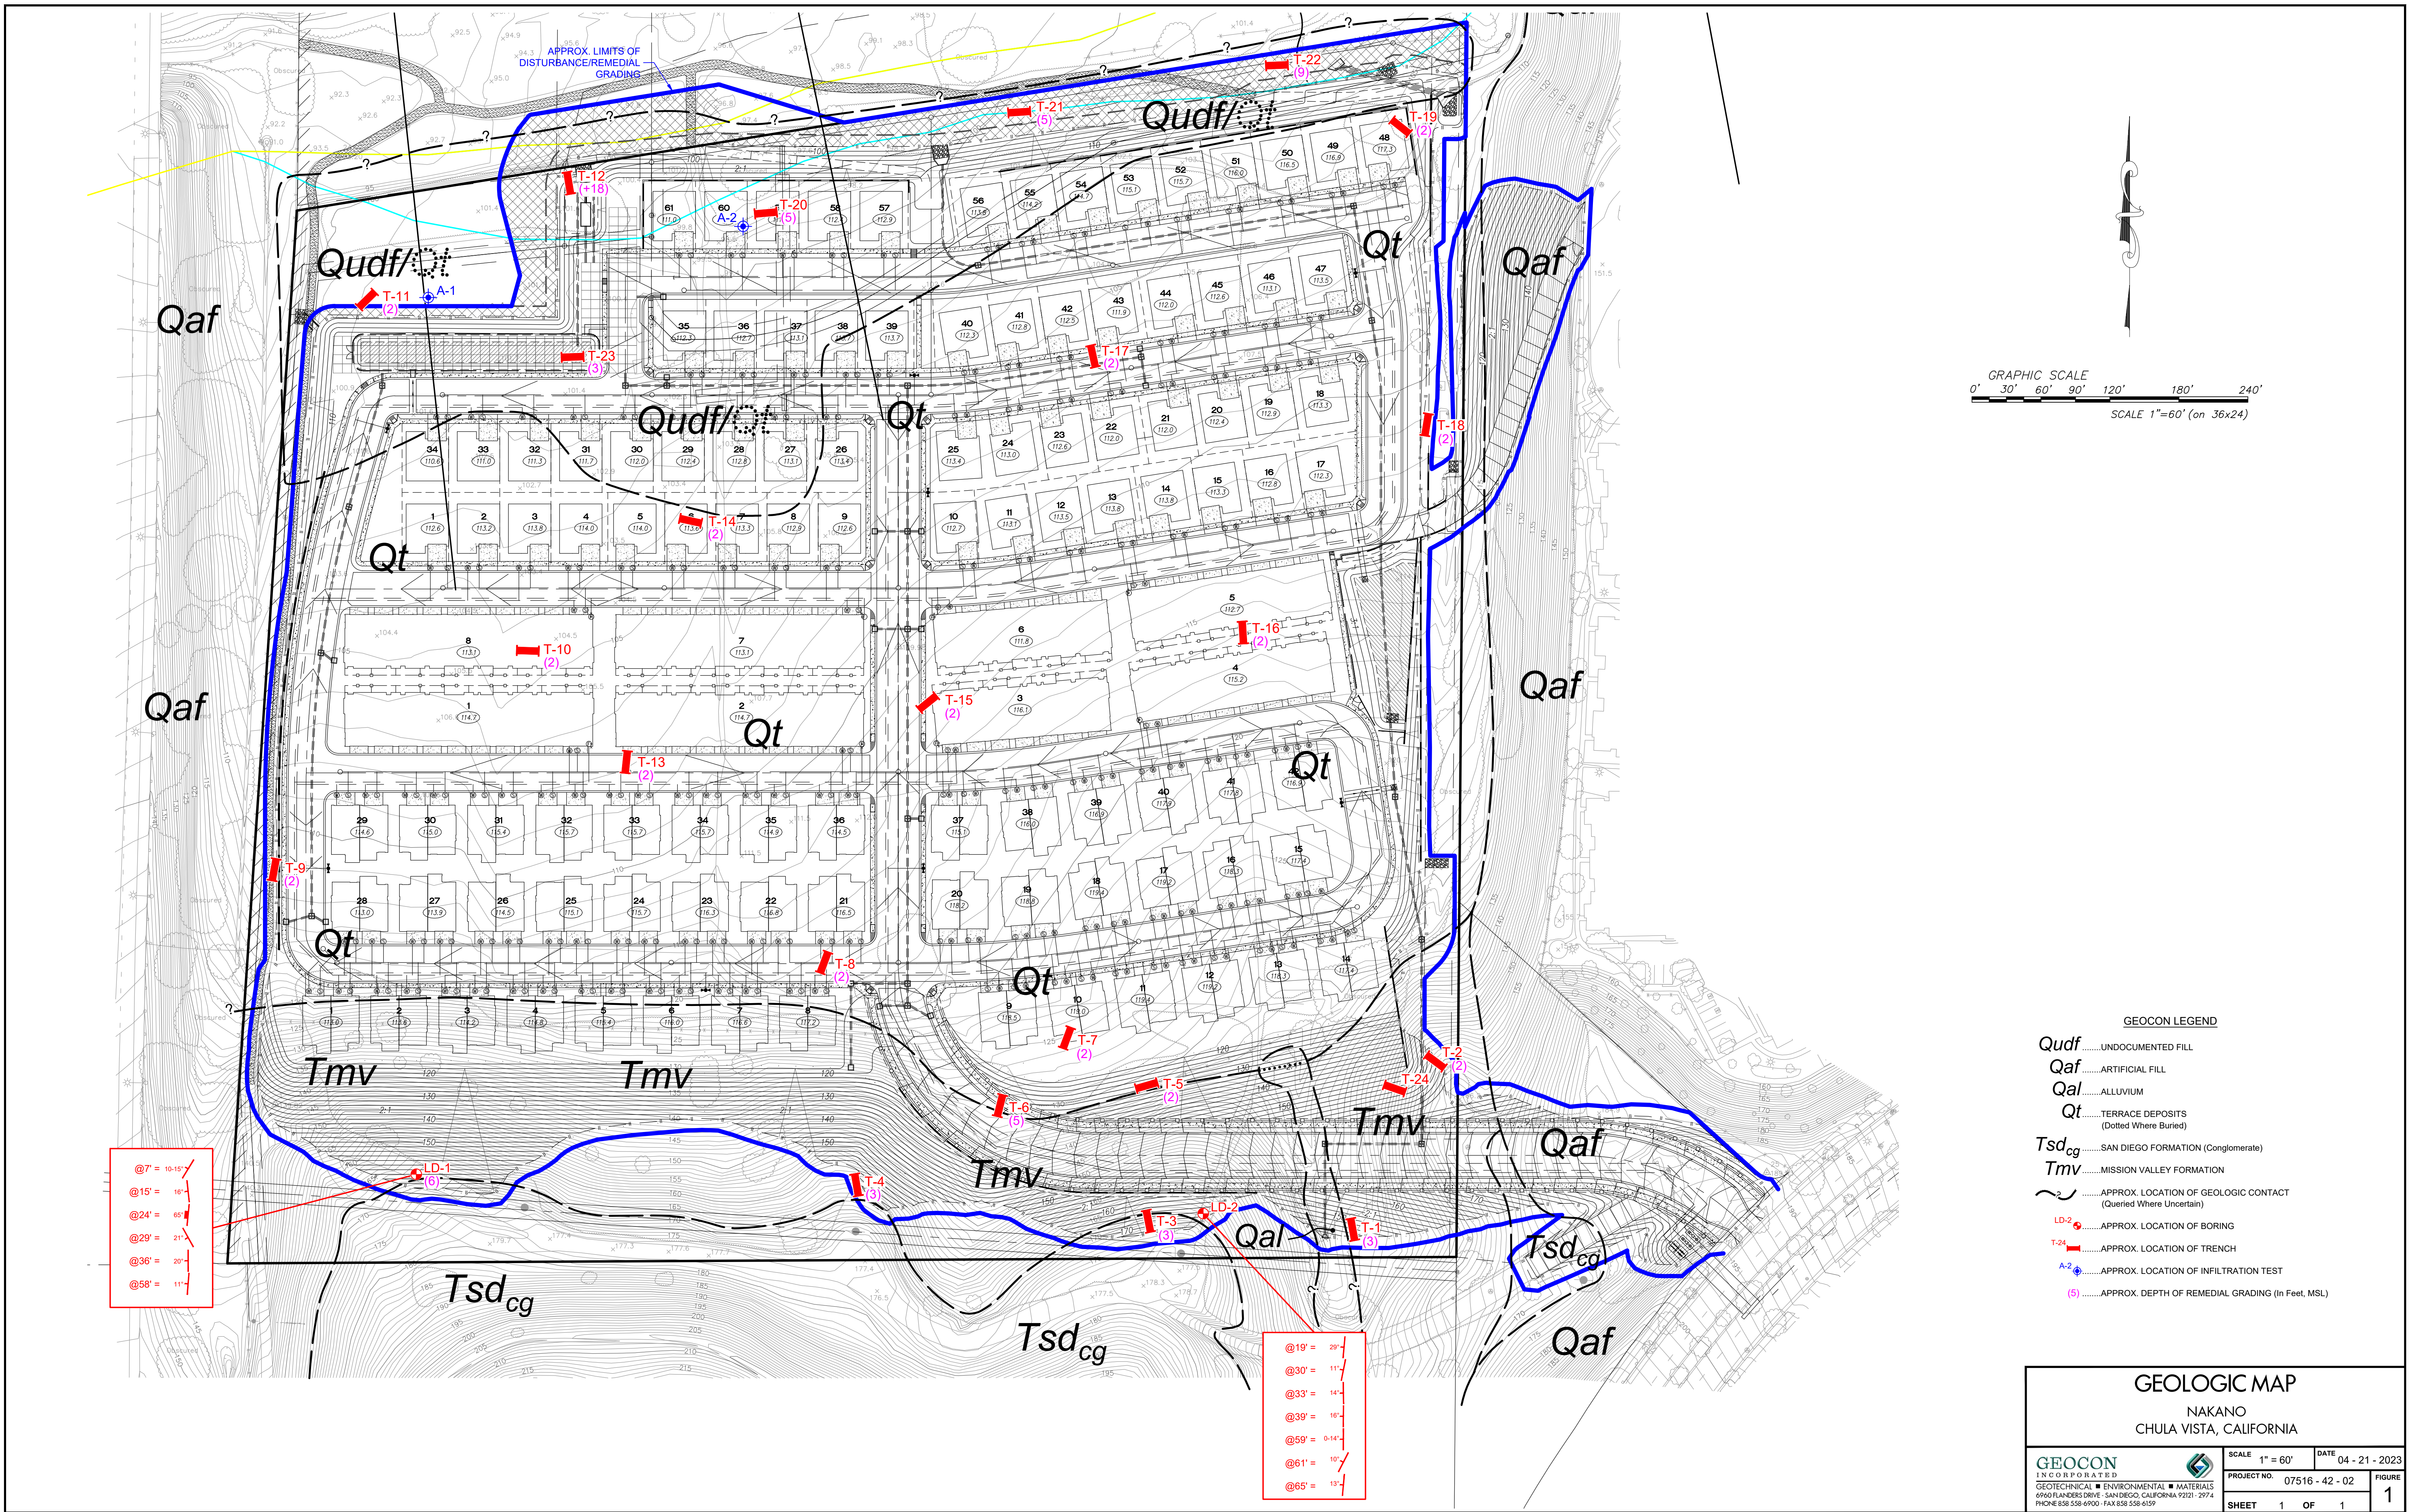
**GEOLOGIC MAP**  
 NAKANO  
 CHULA VISTA, CALIFORNIA

- GEOCON LEGEND**
- Qdf ..... UNDOCUMENTED FILL
  - Qaf ..... ARTIFICIAL FILL
  - Qal ..... ALLUVIUM
  - Qt ..... TERRACE DEPOSITS  
(Dotted Where Buried)
  - Tsd<sub>cg</sub> ..... SAN DIEGO FORMATION (Conglomerate)
  - Tmv ..... MISSION VALLEY FORMATION
  - ~ ..... APPROX. LOCATION OF GEOLOGIC CONTACT  
(Queried Where Uncertain)
  - LD-2 ..... APPROX. LOCATION OF BORING
  - T-24 ..... APPROX. LOCATION OF TRENCH
  - A-2 ..... APPROX. LOCATION OF INFILTRATION TEST
  - (5) ..... APPROX. DEPTH OF REMEDIAL GRADING (in Feet, MSL)

- @7' = 10-15'
- @15' = 16'
- @24' = 65'
- @29' = 21'
- @36' = 20'
- @58' = 11'
