**GEOTECHNICAL  
RECONNAISSANCE REPORT**

**OTAY RANCH TOWN CENTER  
CHULA VISTA, CALIFORNIA**

**FEBRUARY 4, 2022  
PROJECT NO. G2883-52-01**

Subject: GEOTECHNICAL RECONNAISSANCE REPORT  
OTAY RANCH TOWN CENTER  
CHULA VISTA, CALIFORNIA

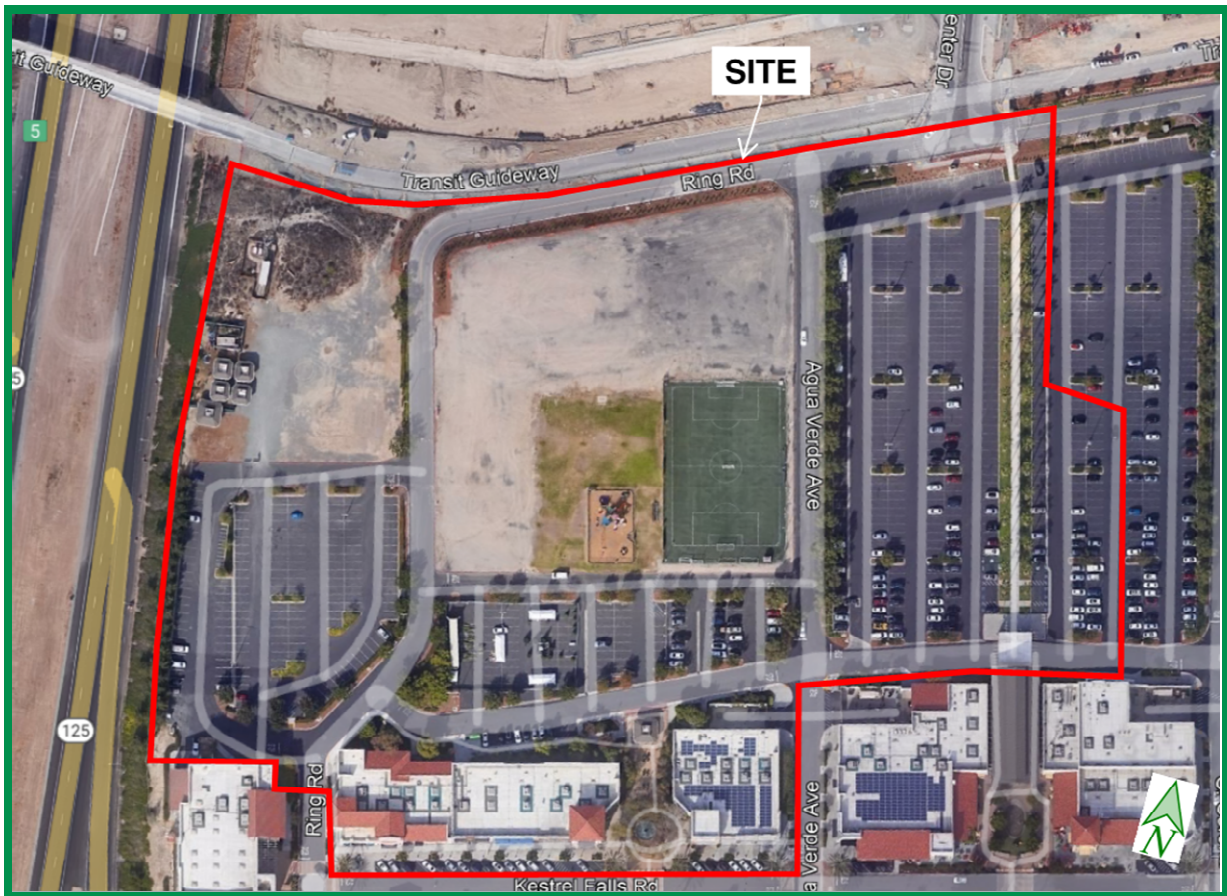
The existing property consists of the northern parking area for the existing Otay Ranch Town Center mall. The area consists of surface grade asphalt concrete parking on the east and southwest, an outdoor soccer area and playground in the central portion with a landscape construction storage area in the northwest portion. The site was graded between 2004 and 2005 with observation and testing services provided by Geotechnics, Incorporated. The site is relatively flat with elevations between 624 feet Mean Sea Level (MSL) and 614 feet MSL, sloping gently to the southwest. An existing 10- to 15-foot-high cut and fill slope exists on the west limits of the site, descending towards State Route 125. The Existing Site Map shows the current conditions at the site. Based on the previous as-graded map, the site was partially situated over the upper portions of two canyon drainages with fill depths ranging up to about 25 feet at the site.

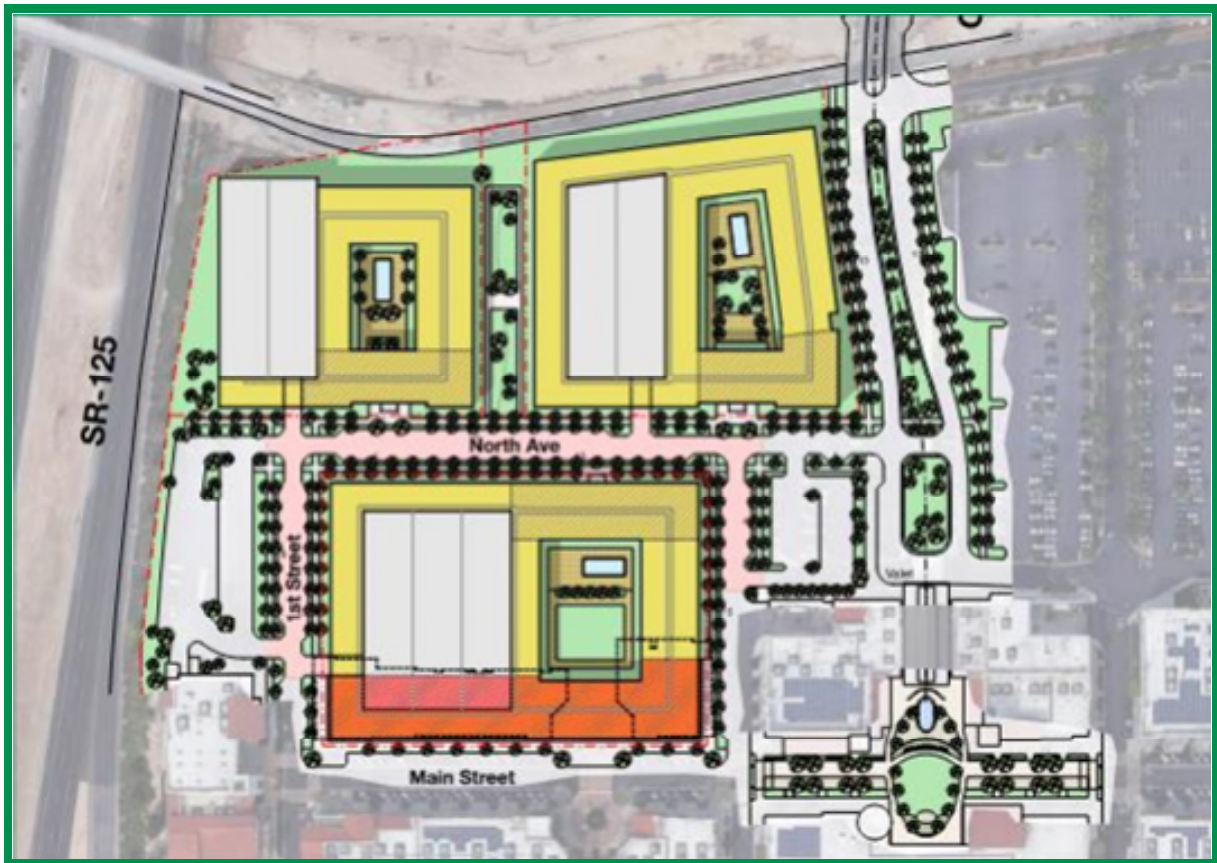
We understand the proposed redevelopment will consist of constructing 3, multi-family residential lots with commercial space, reconfiguring the existing Town Center Drive entrance and installing a new plaza area in the southeast portion of the site with accommodating utilities, flatwork, and landscaping. The Preliminary Site Plan shows a current concept of the proposed improvements.

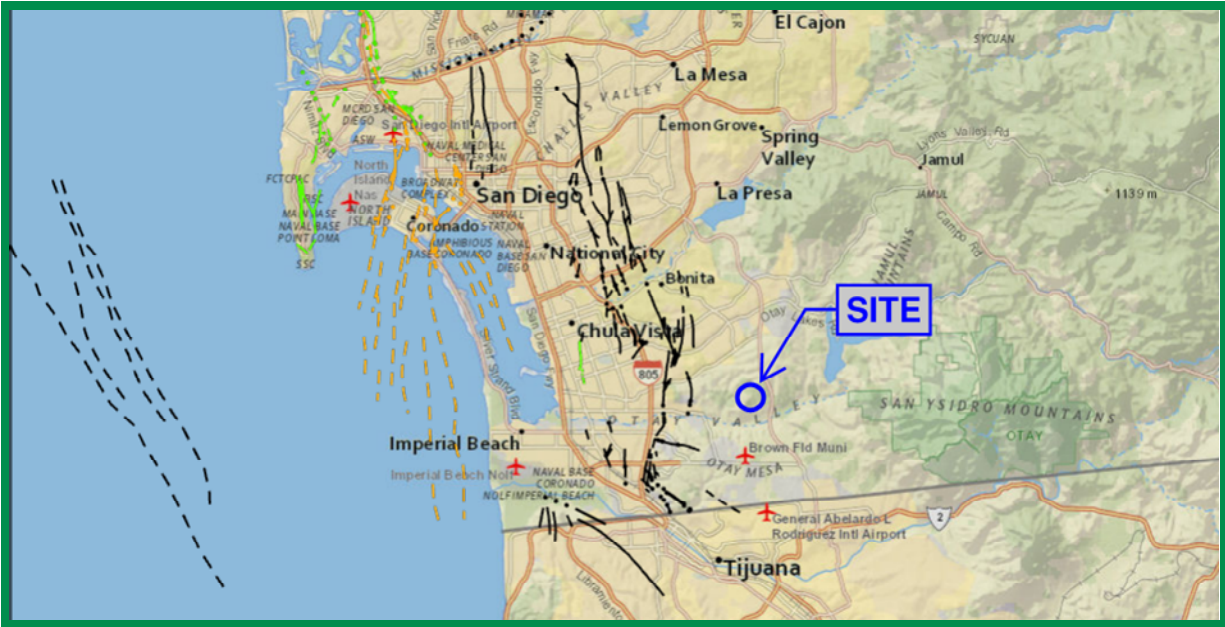
Faults in Southern California

The USGS has developed a program to evaluate the approximate location of regional faulting in the area of properties. The following figure shows the location of the existing faulting in the San Diego County and Southern California region. The fault traces are shown as solid, dashed, and dotted that represent well-constrained, moderately constrained and inferred, respectively. The fault line colors represent fault with ages less than 150 years (red), 15,000 years (orange), 130,000 years (green), 750,000 years (blue, not shown) and 1.6 million years (black).

A review of geologic literature and experience with the soil and geologic conditions in the general area indicate that known active, potentially active, or inactive faults are not located at the site. An active fault is defined by the California Geological Survey (CGS) as a fault showing evidence for activity within the last 11,700 years. The site is not located within a State of California Earthquake Fault Zone.

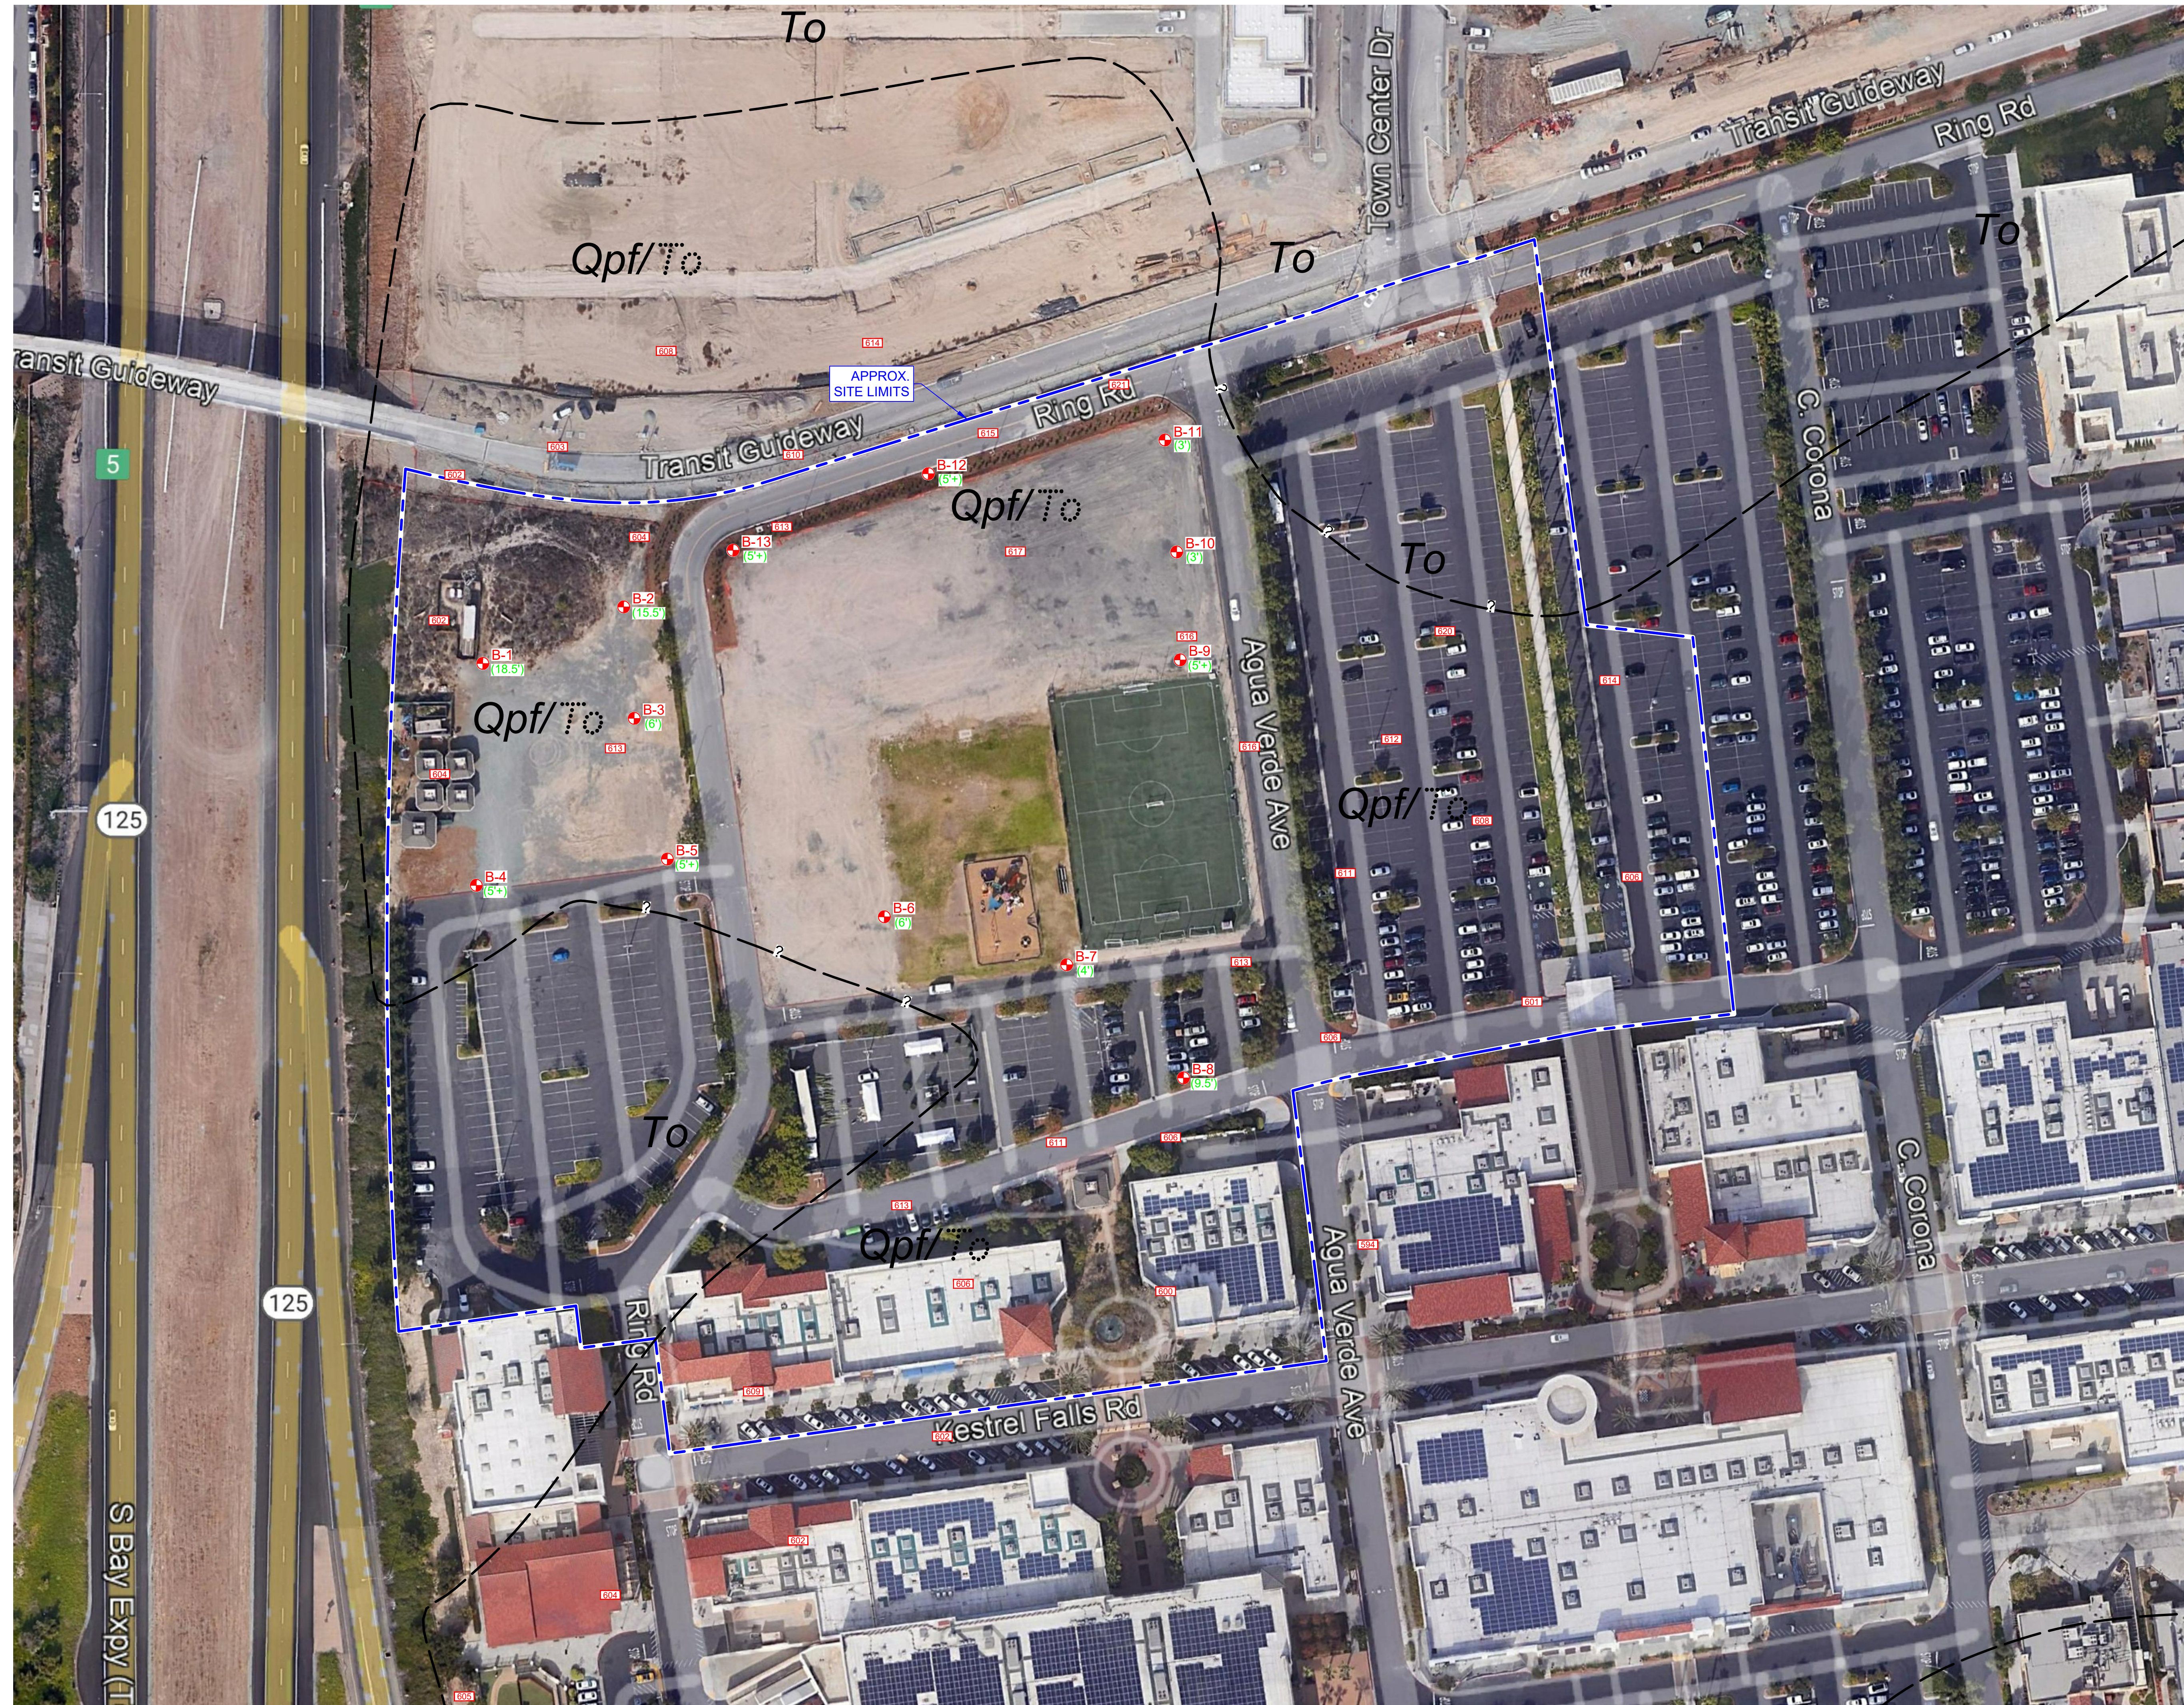
**GEOLOGIC MAP**  
OTAY RANCH TOWN CENTER  
CHULA VISTA, CALIFORNIA

- GEOCON LEGEND**
- Qpf* .....PREVIOUSLY PLACED FILL (Geotechnics, Inc. 2005)
  - To* .....OTAY FORMATION (Dotted Where Buried)
  - .....APPROX. LOCATION OF GEOLOGIC CONTACT
  - B-13 .....APPROX. LOCATION OF BORING (Geocon, Inc. 2014)
  - (5'+) .....APPROX. DEPTH OF FILL (In Feet)
  - E113 .....APPROX. ELEVATION AT BASE OF FILL (In Feet, MSL)

Previously placed fill is present across most of the site based on the referenced as-graded map. The fill depths likely range up to about 25 feet on the site. We expect the fill soil consists of medium dense, damp to moist, sandy silts and clays and possess a “very low” to “high” expansion potential (expansion index of 130 or less) and a “S0” sulfate exposure. We expect the upper 2 to 3 feet of the existing fill will require remedial grading. However, deeper removals may be required during relocation of utilities or from demolishing foundations. The previously placed fill is suitable for the support of the proposed fill and structural loads.
